## Restoration of the facade of the church of San Pedro Apostol in Agost, Spain

This work describes the studies and the intervention carried out for the restoration of the facade of San Pedro Apostol in the parish church of Agost. This facade was made at the end of the 18th century in limestone. After an initial inspection and graphic survey of the facade, the lesions, their origin, and the solution to them were identified by using advanced restoration techniques. The stone elements damaged or destroyed by the passage of time are composed of calcite, dolomite and silica, with plaster joints, and have been reconstructed either through the use of new elements or, for the most part, through systems of recovery of the initial volume with the use of a light core of polystyrene, lime mortars, expanded clay, fiberglass and carbon together with infiltrations of resins in the disintegrated areas. After a delicate intervention process using innovative techniques, the facade was completed in June 2023.

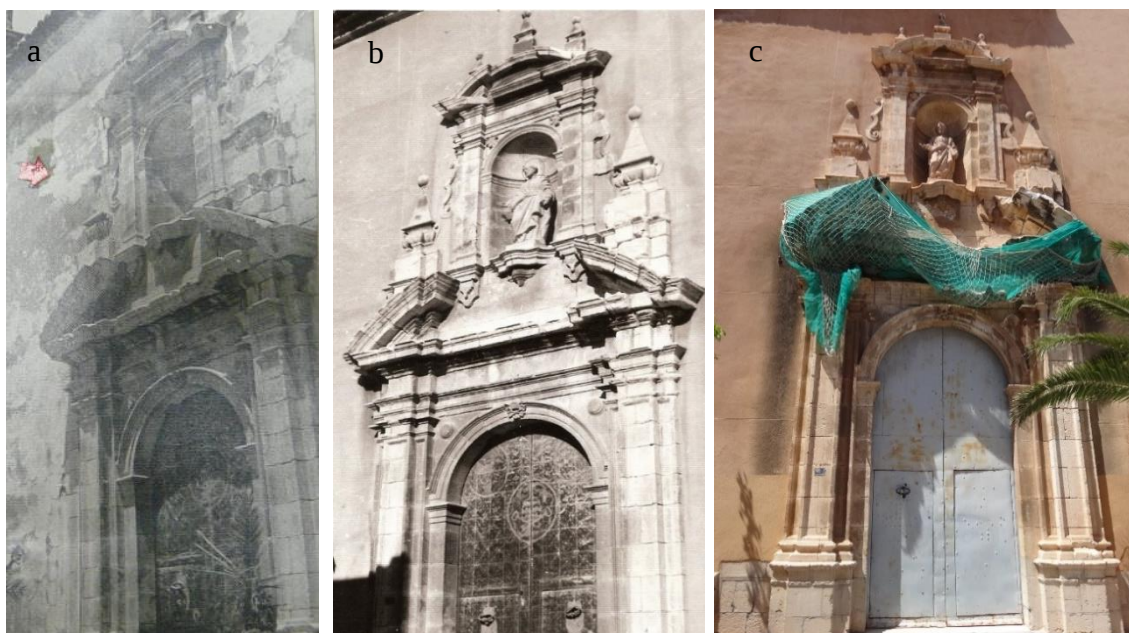
During the Spanish Civil War (1936-39) the building suffered considerable damage and even suffered a fire. The existing images on both facades were destroyed, particularly the image of Saint Peter on this facade (Figure 2a). After a major intervention of the building in the 1960s, there have been no further major structural interventions affecting this facade (Figure 2b). In 2014, some detachments were detected in elements of this facade and a protective net had to be installed, which had to be replaced again in 2021 due to detachments of stone elements (Figure 2c). In 2023, the restoration process began following a study and a project carried out at the University of Alicante.

Figure 2. Photographs of various historic situations (a) 1964, (b) 1973 (c) 2021

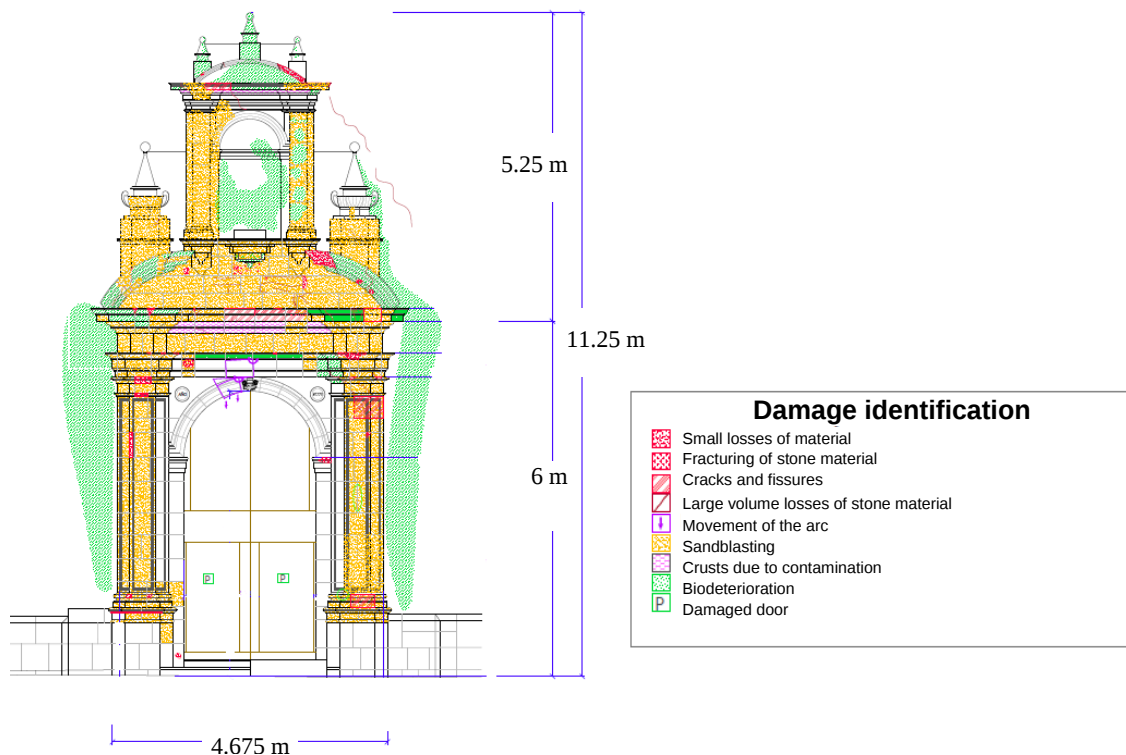
Based on the geometric information obtained, as well as the lesions observed, Figure 5 shows the situation of the doorway.

Figure 5. General geometry of the doorway. Damages observed.

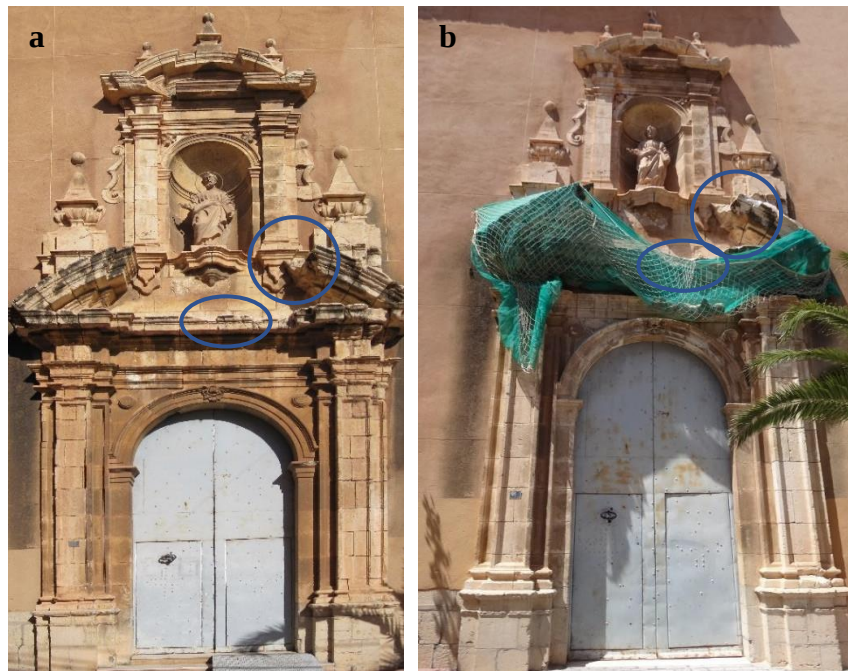
The facade of San Pedro Apóstol was much deteriorated, with stone elements missing, such as several fragments of the cornice that have come loose in recent years. If we compare the images of the facade in 2014 with those of 2021 (Figure 6), we can appreciate the increase in deterioration it has suffered. In 2014, it was recommended that protective nets be installed, as the facade was already showing a high degree of deterioration.

In January 2020, several large fragments fell off and were caught in the protective netting (Figure 6b). In other exposed areas of the portal, where water can be retained, further deterioration has also been observed.

Figure 6. a) Aspect of the doorway in 2014 (Author Javier García Galán; 2014) and b) 2021 (author Yolanda Spairani; own elaboration). The areas with the largest landslides are indicated.

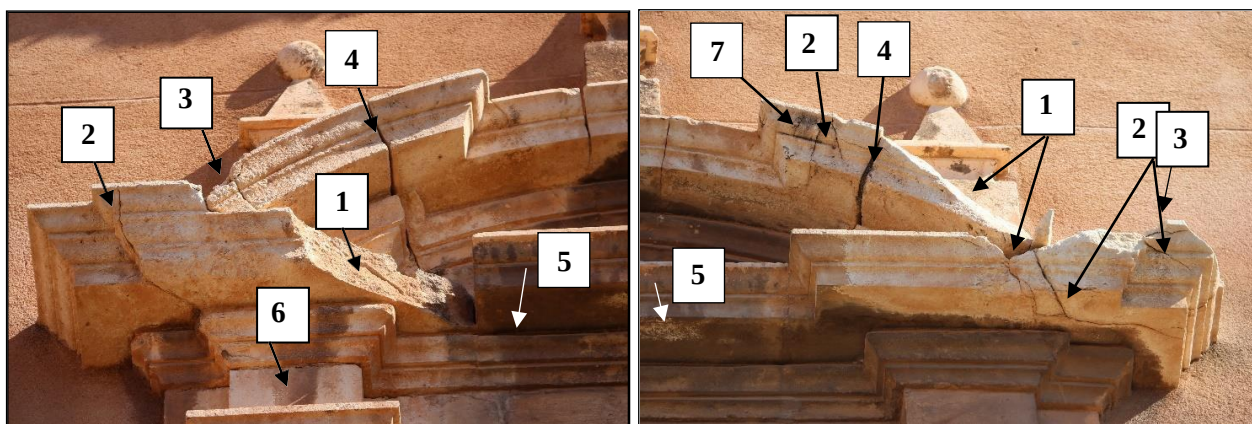
The different lesions observed on the doorway are listed below (Figure 7) in order of severity of the problem and photographs are attached to illustrate each of the different lesions:

1. Detachments of stone fragments
2. Fractures in the stone
3. Small losses of stone material.
4. Widespread loss of grouting material
5. Crusts due to contamination
6. Dirt deposits
7. Bio deterioration
8. Alteration of surface patina

Figure 7. Detail of the lesions in the upper area. Deposits of dirt can be seen in the areas protected from rain.

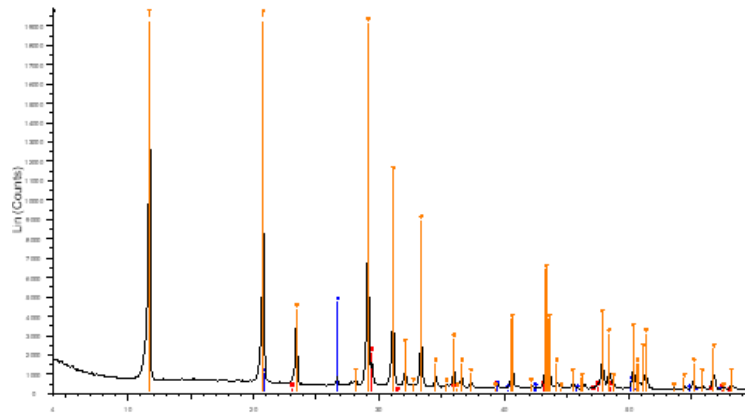
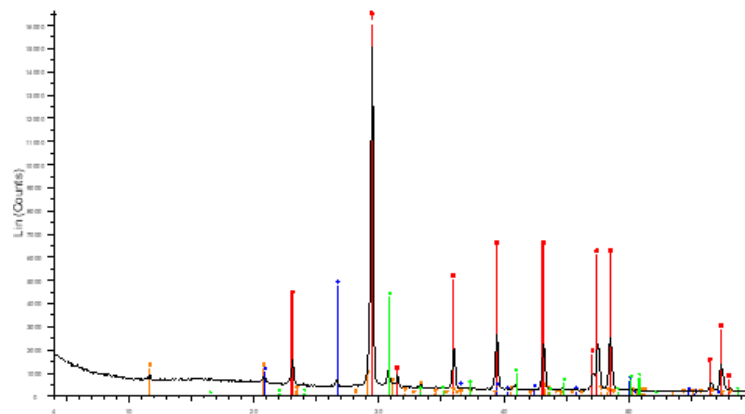
Figura 8. Diffractograms

The grout mortar, the calcarenitic stone and the grey limestone of the plinth have been analysed. The mortar was found to be gypsum as shown by the XRD results (Figures 8a and 8b). The stone is mainly composed of calcite (calcium carbonate  $\text{CaCO}_3$ ), with some dolomite (Calcium magnesium carbonate  $\text{CaMg}(\text{CO}_3)_2$ ), quartz (mineral composed of silica  $\text{SiO}_2$ ) and gypsum (Calcium sulphate  $\text{CaSO}_4$ ) as can be seen in the following diffractograms in their composition, where the orange peaks in the graph correspond to gypsum, limestone to red, siliceous to blue and dolomite to green.

a) Diffractogram of the mortar from the doorway of San Pedro in Agost.

b) Diffractogram of the calcarenite stone from the doorway of San Pedro in Agost.

These results indicate a significant presence of calcium sulphate (orange peaks) in existing mortars that are exposed to atmospheric agents (rainwater), and therefore its weakness and deterioration as a hygroscopic material (gains and losses of water in its molecular composition  $\text{CaSO}_4 \cdot n(\text{H}_2\text{O})$ ) which makes it not very stable; but also this presence of sulphates can accelerate stone degradation as the stone contains the magnesium of the dolomite and very harmful salts such as magnesium sulphates can be produced (Grossi and Esbert, 1994), (Benavente, 2002, 2021). (Figure 9).

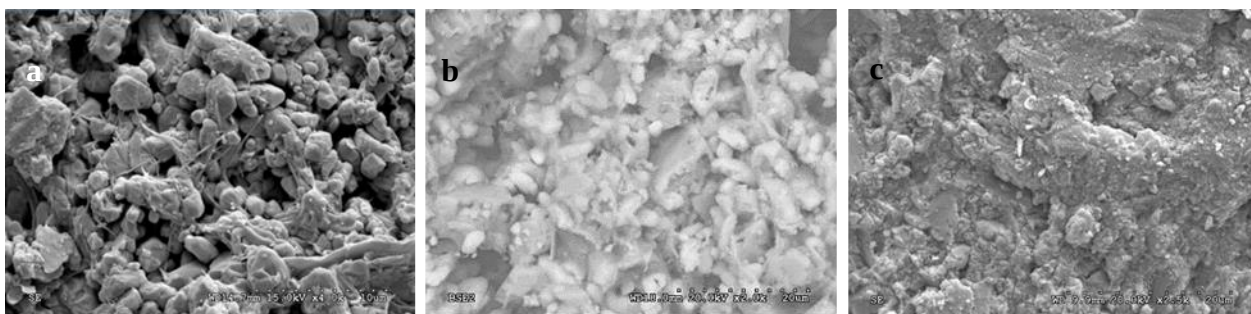
Figure 9. Microphotographs of the materials that make up the doorway of San Pedro de Agost. a) Calcarenitic stone, showing clays and abundant porosity. b) Gypsum mortar with signs of recrystallisation. c) Black limestone with occasional salts..

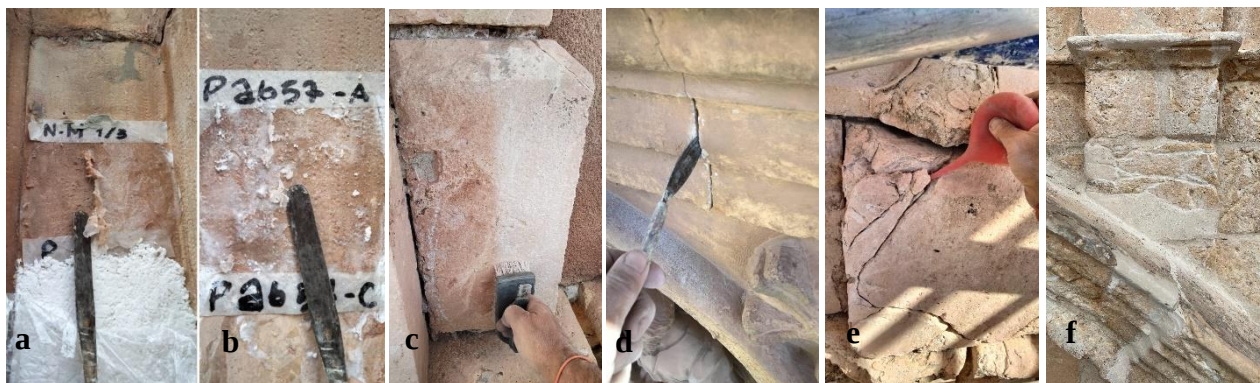
Figure 11. Different aspects of pre-testing of crack cleaning and crack sealing.

The following product has been applied: *Arbocel* (cellulose pulp) with different products such as distilled water and AB57 on an inconspicuous area of the doorway. In both cases it was protected with plastic film to prevent the liquid from evaporating too quickly. It was first left to act for 2 hours, then for 4 hours, and it was observed that in both cases more time was needed, so it was left to act for 24 hours until it was cleaned (figure 11). The result obtained with water was not satisfactory, as hardly any adhering dirt had been removed. With AB57 it worked well. A technique has also been tested which is applied in liquid form and once applied solidifies, trapping the surface dirt in a period ranging from 1 to 3 days. In our case, it was decided to apply a 33% proportion of strong product with 67% of weak product on the entire front doorway with "Clean Galena" heritage cleaner (figure 11a), in those areas where the soft bristle brush did not remove the dirt.

In the cracks (>1mm), lime grout was injected after previously cleaning them with air (figure 11e) and wetting them with water, in this case "Mape Antique I" of the Mapei brand was used. The joints between ashlar have been cleaned with a spatula (figure 11d) since, as we have seen above, they were made of plaster and were disaggregated. Air is applied to clean internally before injecting lime grout. Once the entire portal was cleaned, the cracks and fissures were sealed with lime grout. The large areas have been reintegrated with a lightweight system designed for this case, as the base stone is very degraded, and the aim has been to subject the supporting stone to as little external stress as possible.
