Pathological manifestations in a prestressed concrete flat slab building - a case study: part II - structure reinforcement.

This study presents the recovery and structural reinforcement work conducted on a commercial building and is complementary to the study “Pathological Manifestations in a Prestressed Concrete Flat Slab Building - A Case Study: Part I - Structural Analysis.”

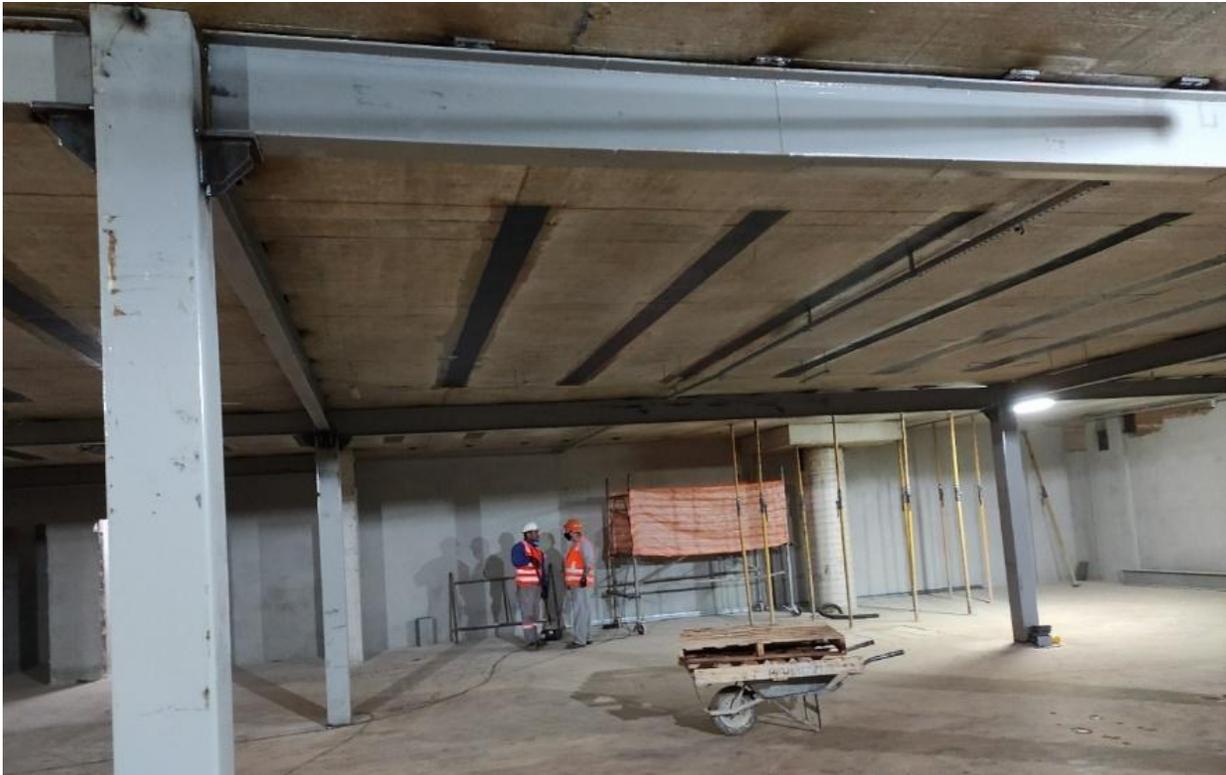
The partially underground level covered by the ground floor slab was defined as parking garage. As such, it had a lower floor-to-ceiling height which impeded the installation of trusses or external prestressed reinforcement. Consequently, the reinforcement project made use of additional columns with pressed concrete piling foundations. Both original and new columns were attached to I-beams connected to plates anchored to the slab in order to achieve the performance of a composite structure. This composite structure was projected for the existing structural load in accordance with standard NBR 8800 (ABNT, 2008) and the method presented by Sarkis (2001). Figure 4 shows the additional columns and I-beams on the underground level. Also visible at the bottom of the ground floor slab are bonded carbon fiber tape segments used to supplement the lack of passive reinforcement in the slab.

Figure 4. Metallic column and I-beam reinforcements in the underground level.

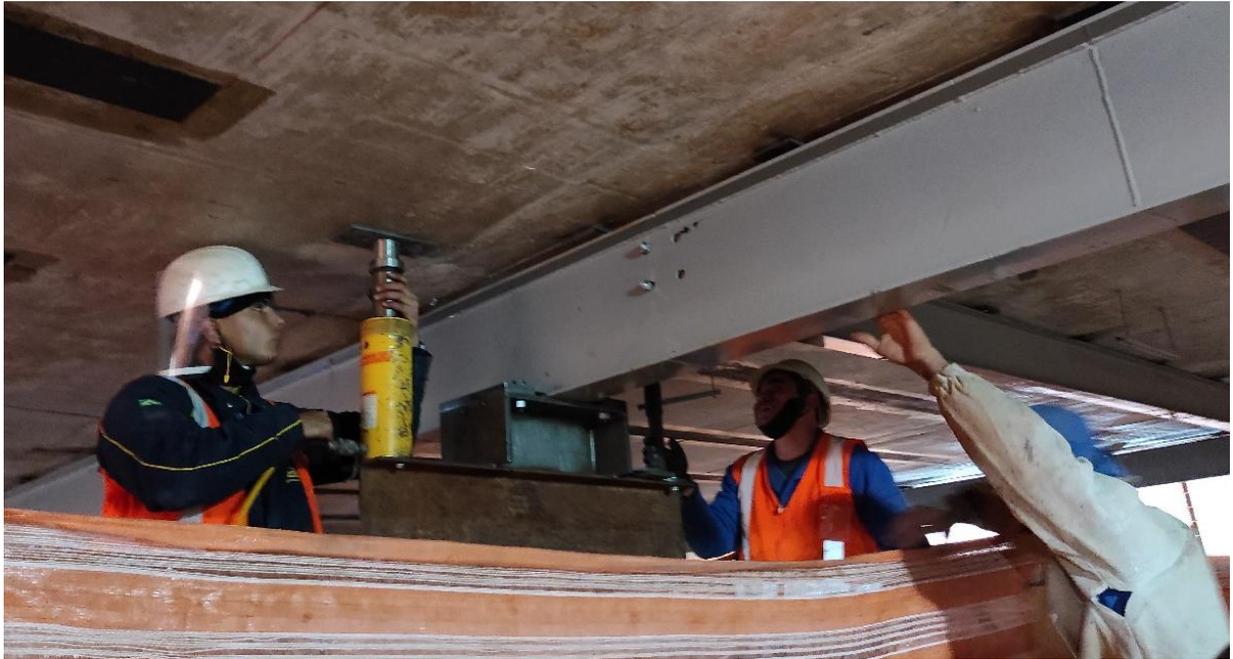
The I-beams were loaded in place by jacking against the slab and making use of its own flexibility. Steel shims in the form of plates or sheets were placed in the span between the deformed beam and the anchored plates. Once relieved from jacking, the beams returned to their original shape and were able to carry part of the load of the slab. Figure 5 shows a jacking procedure being conducted on an I-beam.

Figure 5. Workers jacking an I-beam for insertion of metallic shims.

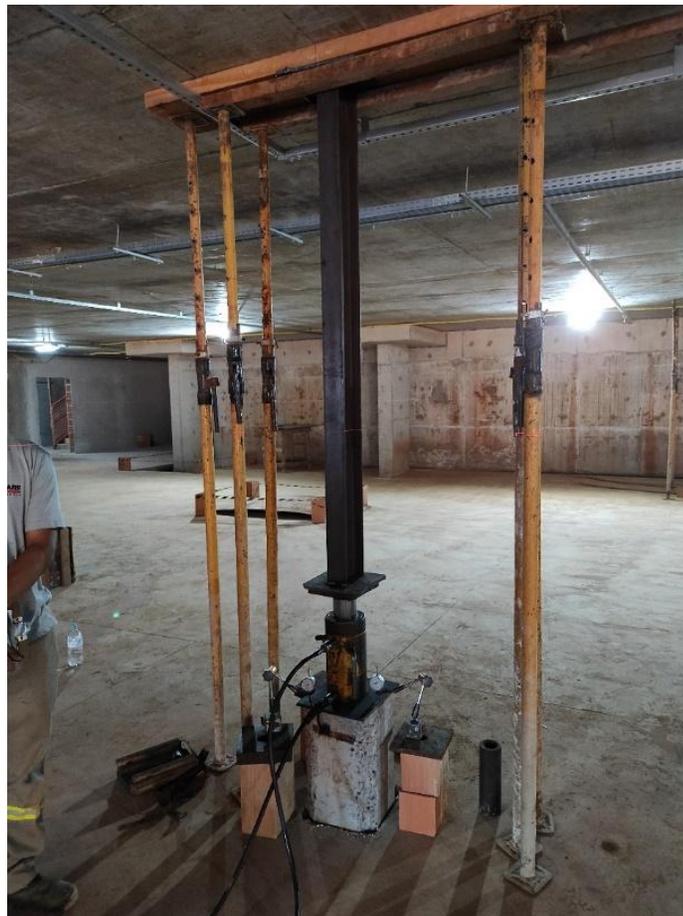
The concrete pressed pilings were installed by first digging holes in the underground floor with portable equipment due to the restriction presented by the low floor-to-ceiling height. Once the excavation depth reached the allowed extent of the equipment, pilings were driven in the holes with a hydraulic ram until the necessary strength for a driven pile foundation was reached in accordance with standard NBR 6122 (ABNT, 2019). In this process, poured concrete was used to fix the pilings in place. Figure 6 shows a hydraulic ram being used to drive the pilings into the ground.

Figure 6. Hydraulic ram driving pilings into the foundation.

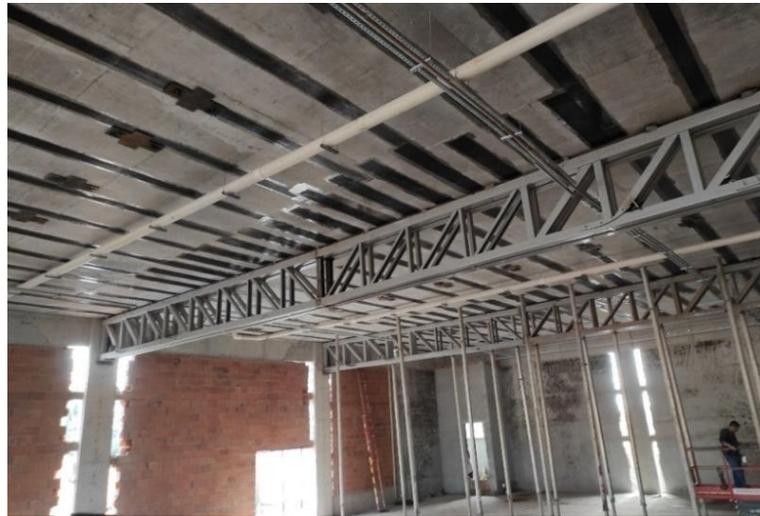
In upper floors, the original architecture project specified a dropped ceiling with a height gap between 90 cm and 110 cm for utility ducts. This gap allowed the installation of steel trusses following the orientation and position of the unbounded tendons of the original structural project. A traditional truss able to reinforce the unsupported gaps and sustain current loads was limited by the height gap of the dropped ceiling and was consequently technically and financially not viable. The proposed solution was to solder and anchor the top chord of the truss directly to the slab. This created a composite truss with the slab itself acting as a compressed chord. Figure 7 shows a steel truss reinforcement anchored against the auditorium ceiling (which was also the 2nd floor slab) creating a composite slab.

Figure 7. Metallic trusses anchored on the auditorium ceiling (2nd floor slab).

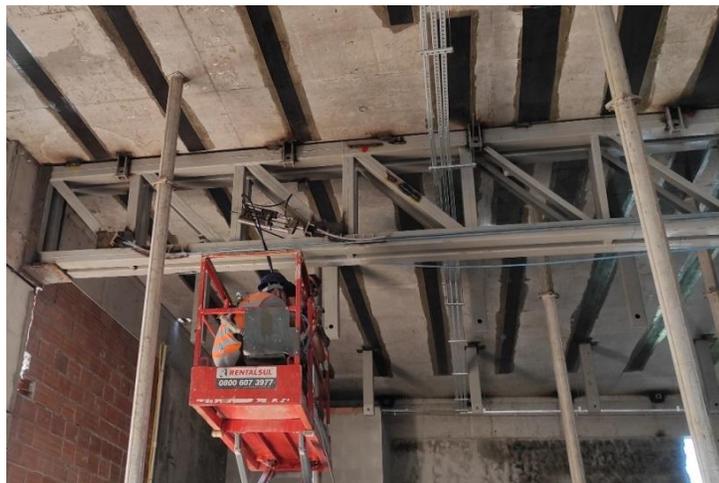
Trusses were installed with the same procedure as the I-beams of the underground floor: jacking against the slab for mounting so that once the jacks were removed, the truss returned to its original shape and carried part of the load of the slab. Along the lower chord of the truss, tensile stresses were mitigated with horizontal prestressing cables along the bottom surface. Some trusses had a further inclined prestressed cable running through its center. Figure 8 shows the installation of a horizontal cable on the lower chord of a truss.

Figure 8. Jacking of horizontal prestressed cable on the truss.

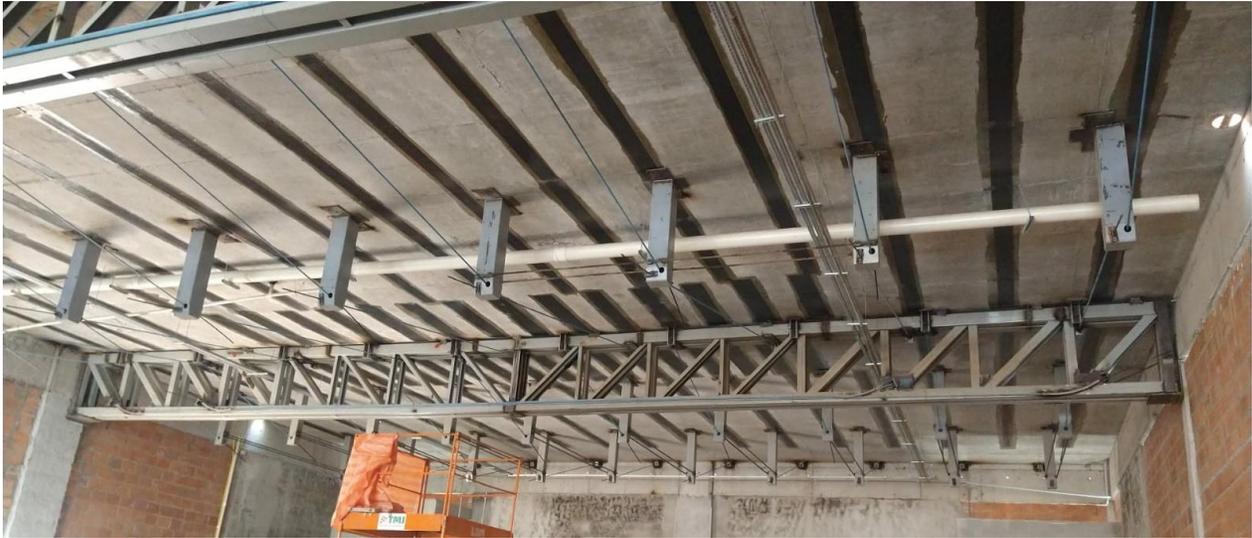
External prestressing was applied perpendicularly to the steel trusses. This prestressing consisted of cables passively anchored to the slab near the top chord of the truss and actively anchored on deviators installed in the unsupported span in order to facilitate jacking. The distance between external prestressed cables was determined iteratively by simulating their presence as external loads at their locations until edge stresses of the 1-D element models were within limits set by standards. Figure 9 shows installed external prestressed cables on the roof of the auditorium (2nd floor slab).

Figure 9. External prestressed cables installed on the roof of the auditorium (2nd floor slab).

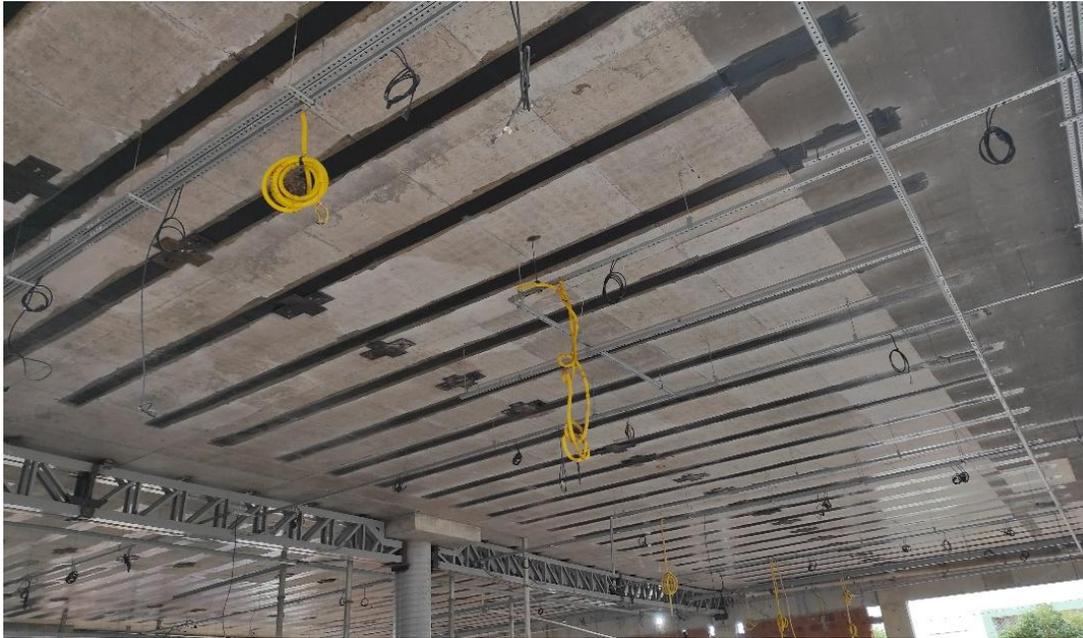
The original structural project contained a Q196 passive positive reinforcement in the lower face of the slab. This consisted of a square mesh with bars 5 mm in diameter spaced 10 mm apart for a total steel area of 1.96 cm²/m, which was less than the minimum required for a slab 25 cm thick. In order to supplement strength in regions with less than the minimal steel area, carbon fiber overlays were applied along the same direction as the tendons. These were applied on the lower face of all slabs of all floors of the structure. Note that in the perpendicular direction to the tendons, the original passive reinforcement was sufficient since the applicable version of standard NBR 6118 (ABNT, 2014) at the time allowed minimum reinforcement to be halved in the secondary direction of a slab. Figure 10 shows carbon fiber strips applied at the bottom of the 2nd floor slab.

Figure 10. Carbon fiber strips installed at the bottom of the 2nd floor slab.

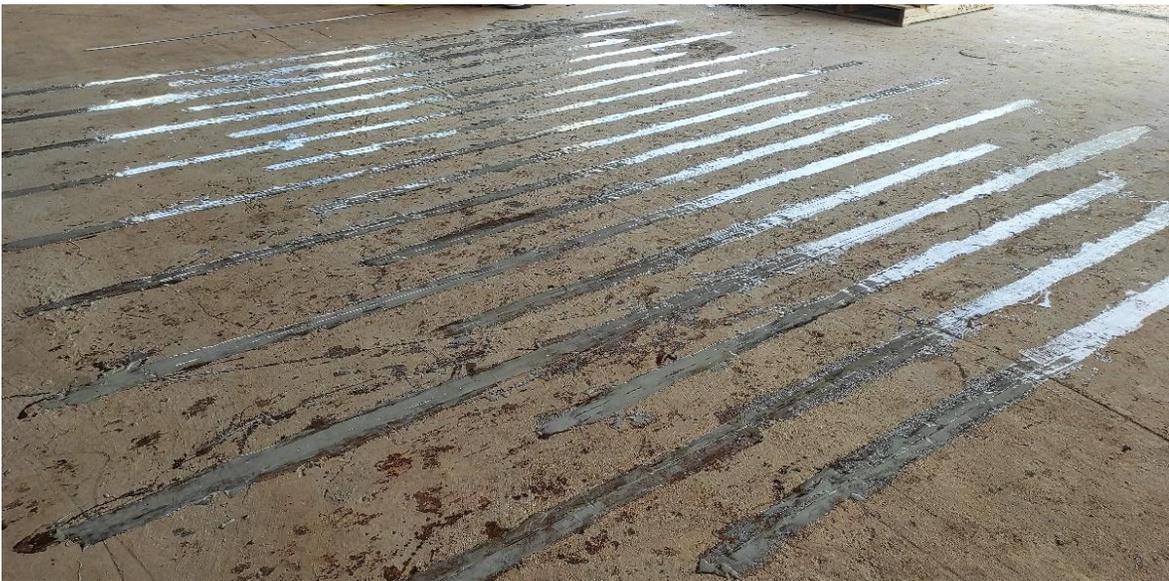
The analysis identified regions with the occurrence of negative bending moments on the top face of some slabs especially above the locations of the steel truss reinforcements. Consequently, negative reinforcements were required and were applied in the form of cut in carbon fiber tape inserts as shown in Figure 11. These were applied to the slabs on the 2nd, 3rd and 4th floor slabs.

Figure 11. Sample application of cut in carbon fiber tape insert on the top of a slab.

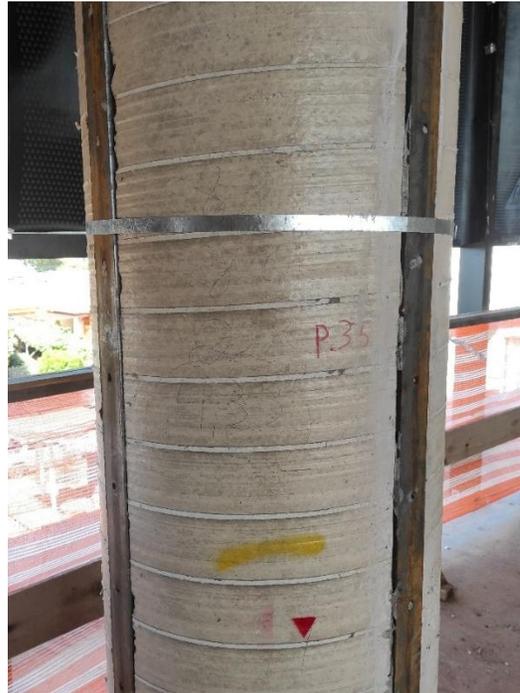
Structural analysis also identified the need for reinforcement on some columns. Two types of reinforcements were used depending on the geometry of the column. Round columns were reinforced with T-shaped metallic profiles inserted into the column lengthwise and bonded to the concrete with structural epoxy as shown in Figure 12. Rectangular columns in the underground level were reinforced with bands of carbon fiber overlay bounded around the perimeter and L-shaped metallic profiles bonded lengthwise at the corners as shown in Figures 13 and 14.

Figure 12. Round column reinforcement with metallic profiles.

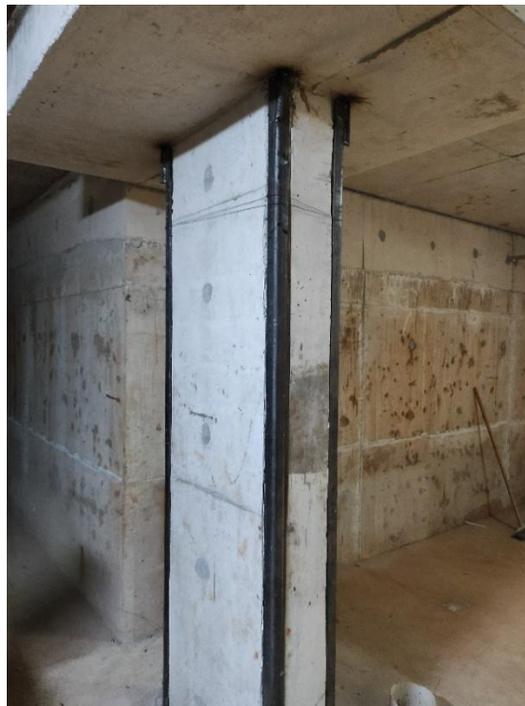
Figure 13. Rectangular column reinforcement with metallic profiles bonded at the corners

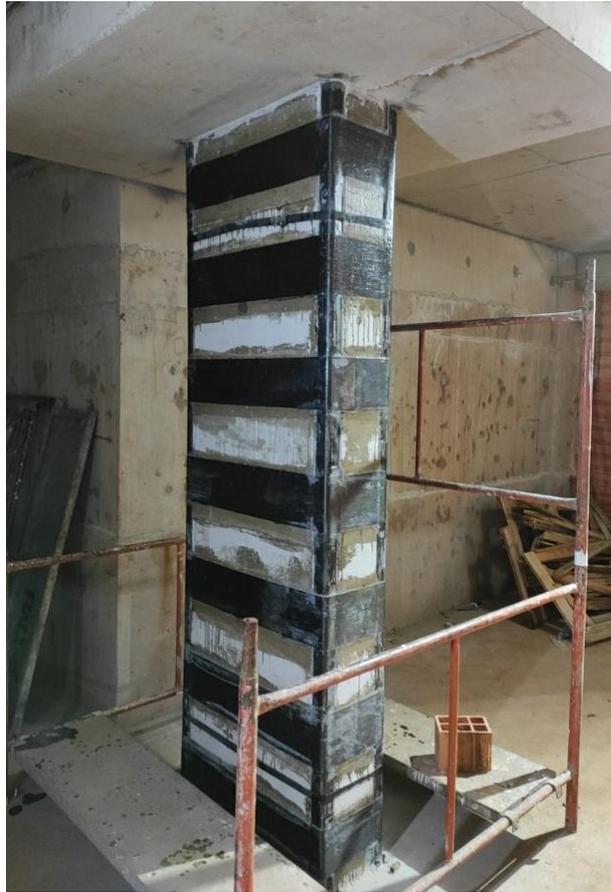
Figure 14. Carbon fiber overlays reinforcement bounded around a rectangular column.

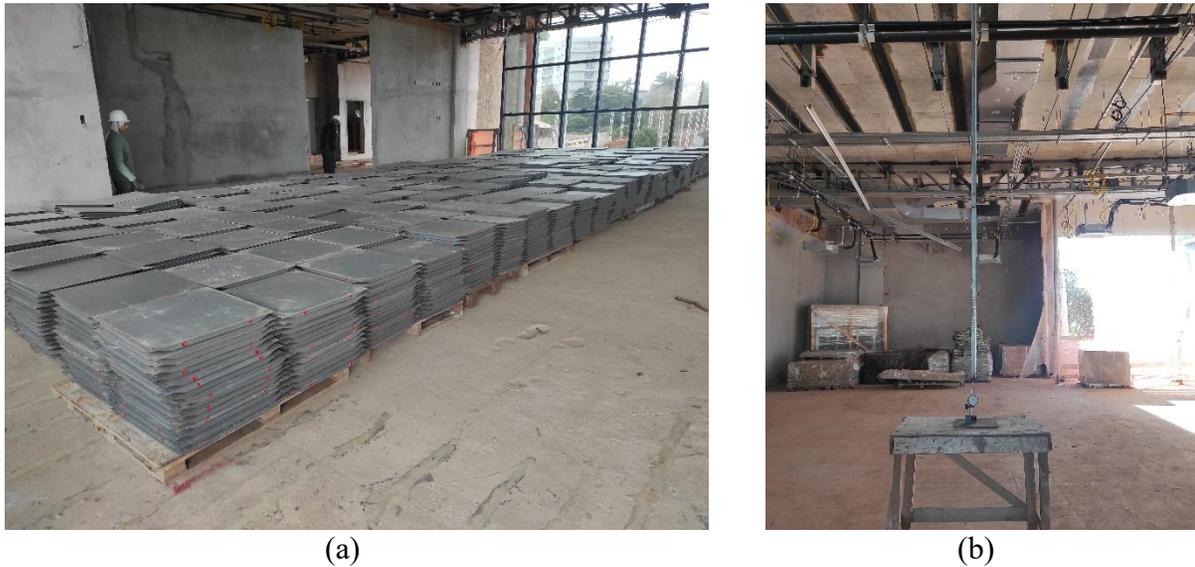
After execution of the structural reinforcement project, structural behavior was observed to be similar to the results from the simulations. Nonetheless, load tests were performed in order to ensure the safety of the reinforced structure. In total, 17 load tests were performed on different floors in accordance with procedures of standard NBR 9607 (ABNT, 2019) as shown in Figure 17.

Figure 17. (a) load test on the 2nd floor slab with floor tiles and (b) equipment for measurement of deflection arrow at a point defined in the structural model.
