Structural assessment of an existing reinforced concrete building using a complementary approach based on visual inspection, non-destructive testing, and load testing.

This study aims to evaluate the structural suitability of an existing reinforced concrete building. The methodology is based on the integration of visual inspection, non-destructive testing (rebound hammer, ultrasonic pulse velocity, and infrared thermography), and load testing on slabs. The results reveal unfavorable conditions, with material heterogeneity, internal degradation, and non-uniform structural behavior. Limitations include the absence of destructive testing and detailed structural information. The main contribution of the study lies in the integration of assessment techniques at different levels of the structural system. The structure cannot be considered fully suitable for use in its current condition.

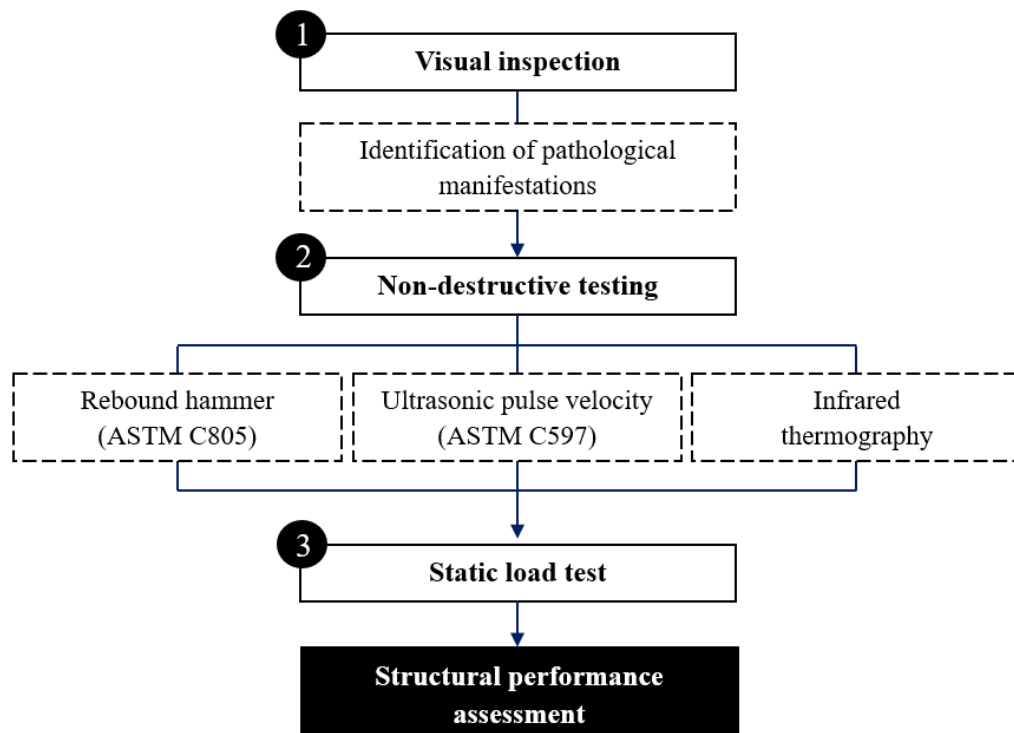
Figure 1. Proposed procedure.

The adopted methodology is based on the complementary application of NDT and static load testing, constituting a proposal for the structural assessment of an existing structure through a case study approach. Figure 1 presents the detailed procedure followed in this study.

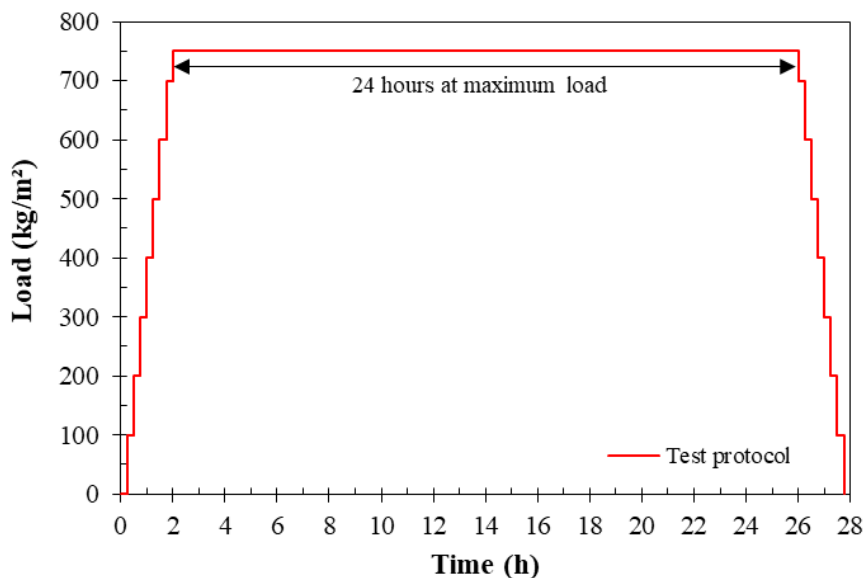
Figure 4. Loading and unloading test protocol.

The load was applied progressively in eight stages, with increments of 100 kg/m² up to 700 kg/m², followed by a final increment of 50 kg/m² to reach the total test load. Once the maximum load level was reached, it was maintained constantly for a period of 24 hours in order to evaluate the time-dependent behavior of the slab. Subsequently, the system was gradually unloaded, also in eight stages. Figure 4 illustrates the procedure followed during the execution of the load test.

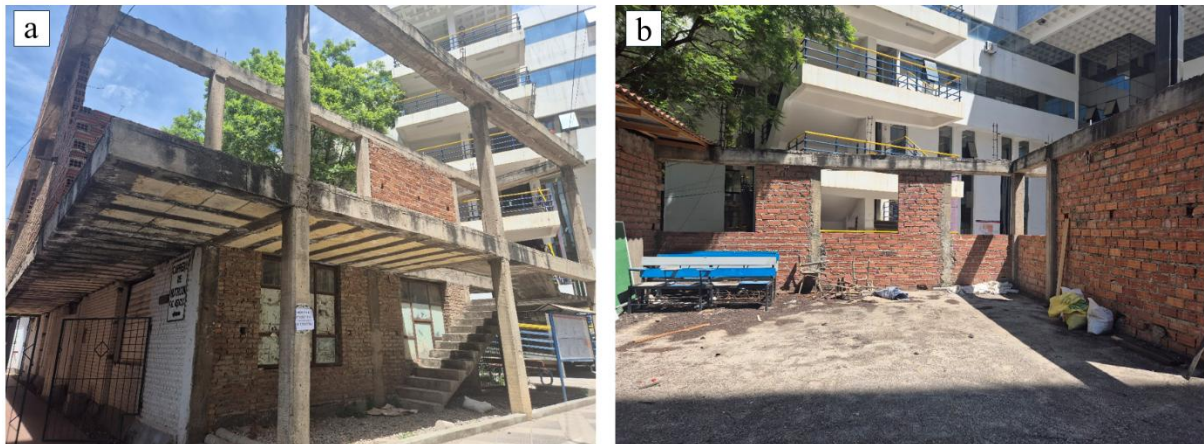
Figure 5. (a) General view and (b) upper floor of the building.

Figure 5a shows a general view of the structure, highlighting its direct exposure to the environment. Overall, advanced concrete degradation is observed, characterized by the presence of dark stains associated with moisture and whitish surface deposits, indicating leaching and efflorescence processes (Smith & West, 2021; Nogueira Diniz *et al.*, 2023). Additionally, signs of concrete carbonation are evident, along with advanced reinforcement corrosion processes. Figure 5b presents the upper floor slab, where the absence of finishes and protective systems can be observed, as well as a surface directly exposed to environmental conditions. Surface irregularities, accumulation of dirt, and concrete disintegration are identified, conditions that justified the execution of the static load test.

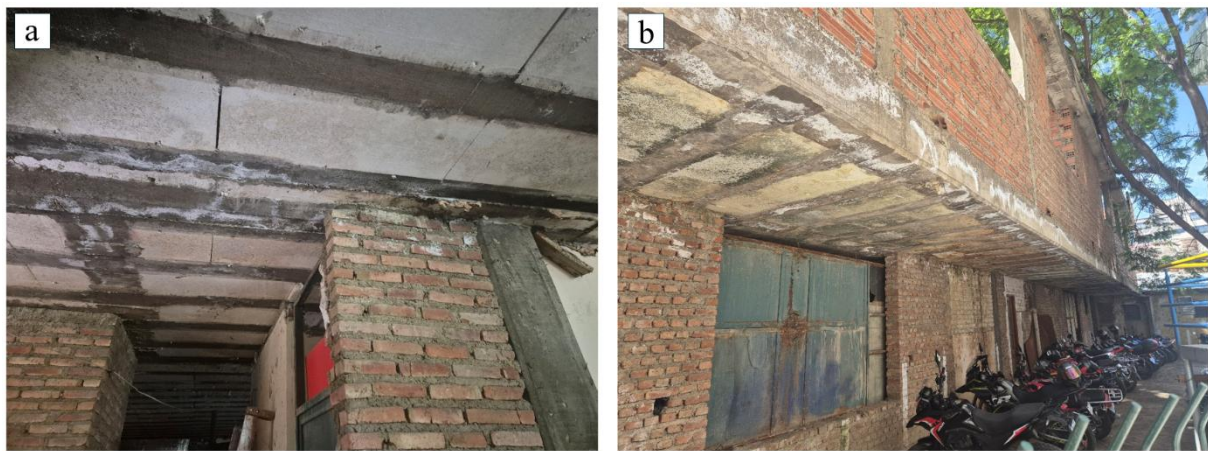
Figure 6. Underside of: (a) slab and (b) cantilever.

The underside of the slabs shows generalized deterioration (Figure 6), characterized by the presence of dark stains, leaching, and efflorescence. Additionally, areas with surface irregularities and local discontinuities were identified, particularly near supports and beam–column joints, where deterioration is more pronounced. These pathological manifestations indicate prolonged exposure to environmental conditions, mainly moisture, as well as cover detachment, factors that affect material quality and the mechanical response of structural elements (Krentowski, 2021; Richardson, 2023).

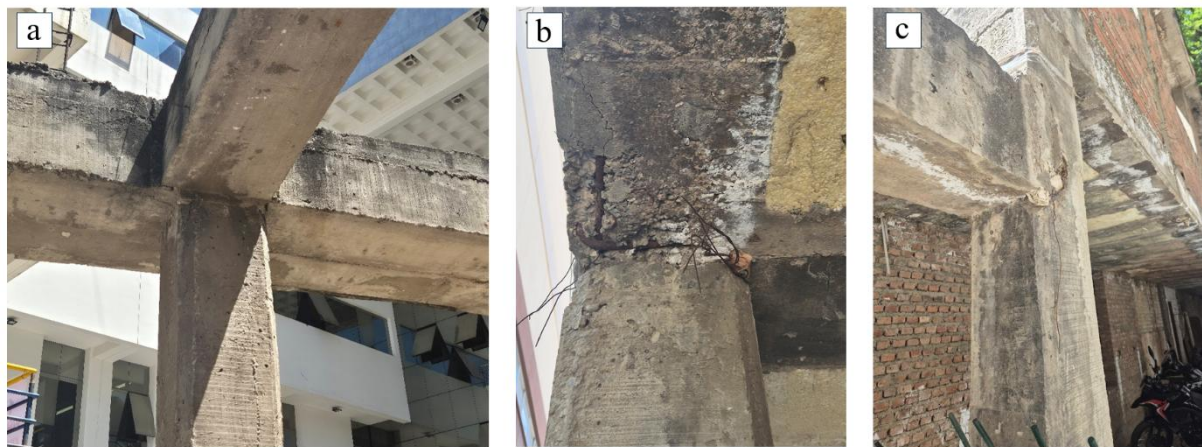
Figure 7. (a) Beam–column joint, (b) reinforcement corrosion, and (c) concrete deterioration.

Figure 7a presents deterioration at beam–column joints, where areas with cover loss, cracking, and alteration of the concrete surface were identified. These regions correspond to critical areas of the structural system, indicating vulnerability of the building in terms of functionality and safety. Figure 7b shows advanced degradation of elements with loss of cover and exposed reinforcement, accompanied by corrosion products. These manifestations confirm carbonation processes in the concrete and prolonged exposure without surface protection (Fuhaid & Niaz, 2022; Poursaeed & Angst, 2023). Figure 7c shows stains associated with moisture, surface deposits, and localized material loss, mainly in areas near supports and column connections. In general, these observations confirm an unfavorable condition of the structural elements, justifying the application of NDT and the evaluation of structural performance through static load testing.

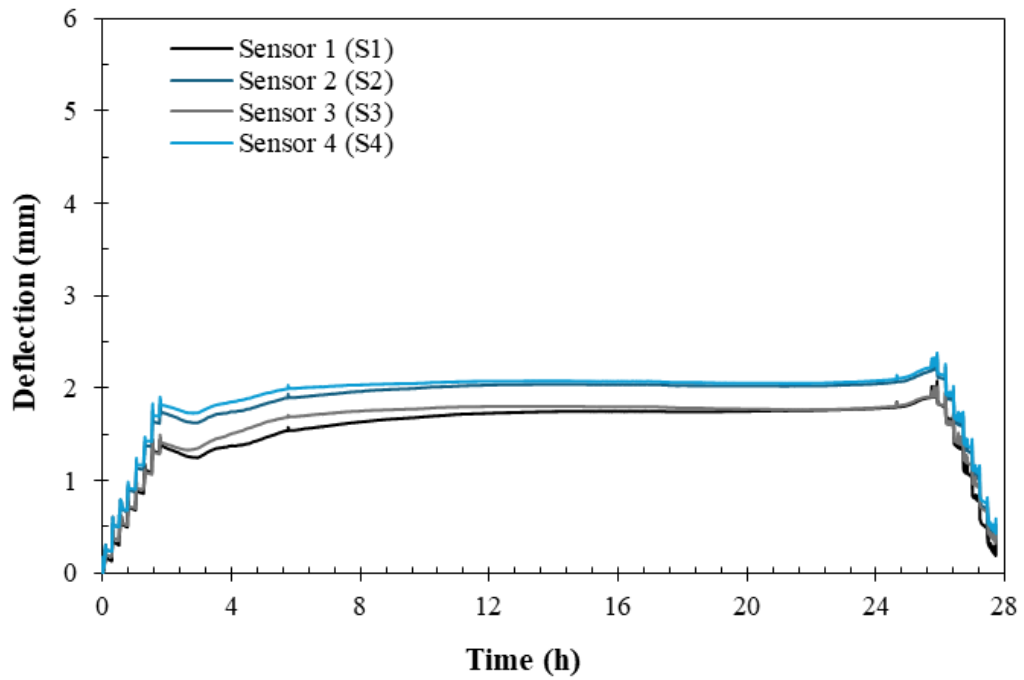
Figure 15. Time evolution of deflection for Slab 1.

For Slab 1, the maximum recorded deflections ranged between 2.016 mm and 2.381 mm. Although these values exceed the absolute deflection criterion of 0.05 in (≤ 1.27 mm), they comply with the maximum allowable deflection based on the effective span of the slab (≤ 3.90 mm). Likewise, elastic recovery exceeded 75% for all sensors, indicating predominantly elastic behavior, with reduced residual deformations and a stable structural response under the applied test load. In contrast, Slab 2 exhibited unfavorable behavior. Maximum deflections ranged between 3.828 mm and 4.983 mm, exceeding both the absolute deflection limit (≤ 1.27 mm) and the span-based criterion (≤ 3.90 mm) for all sensors. Regarding elastic recovery, only sensors S1 and S2 satisfied the 75% criterion, whereas sensors S3 and S4 showed lower recovery values, indicating more significant residual deformations and partially inelastic behavior. Based on these criteria, Slab 1 demonstrates acceptable structural performance under service conditions, while Slab 2 does not meet the primary criteria, indicating unfavorable structural performance.

Based on the decision-making framework proposed in the methodology, the structural assessment allows the classification of the building's performance at different levels of suitability. In this regard, Slab 1 can be considered suitable with restrictions, as it exhibits stable behavior under service load conditions, albeit within a context of material heterogeneity and surface deterioration. In contrast, Slab 2 is classified as not suitable due to non-compliance with serviceability criteria, evidenced by excessive deflections and insufficient elastic recovery. At a global level, the building exhibits non-uniform behavior and a compromised structural condition associated with advanced deterioration, material heterogeneity, and the presence of internal defects identified through NDT. From an engineering perspective, the implementation of intervention measures is required, such as more detailed structural assessment, localized strengthening, or rehabilitation, before considering the building suitable for use.
