## Analysis of overturning stability of a historic cemetery entrance structure.

## **Análisis de la estabilidad ante vuelco de la estructura de entrada a un cementerio histórico.**

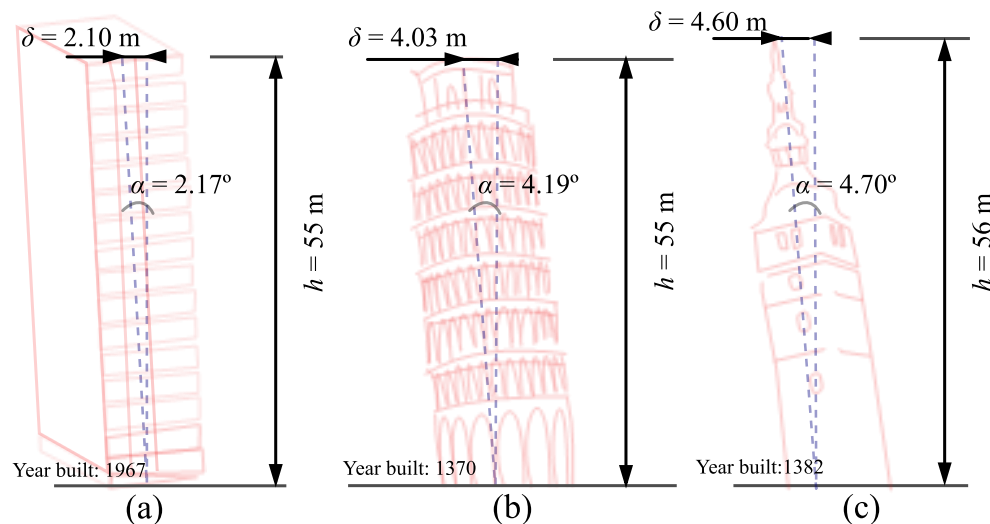
Figure 1. Núcio Malzoni Tower; (b) Pisa and (c) The leaning tower of Bad Frankenhausen  
Note: ( $\alpha = \arctan(\delta/h)$ ).

The use of shallow foundations (footings, blocks, and rafts) is a millennial practice in civil engineering, usually performed to support various structure types at a depth of up to 2.0 m. According to NBR 6122 (ABNT, 2022), shallow foundations transmit the loads to the soil directly by the tensions under the foundation base to a depth of, at most, twice the smaller dimension of the foundation element. Its execution is practical and less costly than the deep foundation. However, their application is less confident than that of deep foundations when it comes to providing long-term safety; due to the risk of soil failure as its properties change over time. The problem of shallow foundation instability is recurrent in old buildings due to several factors, mainly the soil profile, the wear of the material used in the foundation over time, the changing water level, and the ground's excessive vibration. In Brazil, the city of Santos (Brazil) is known as the city of inclined buildings, where about 10% of the city's buildings constructed on the Santos waterfront in the 1960s have a slope problem due to vertical displacements caused by densification of the fine soil over the marine-type soil along the time. The best-known case is the Núcio Malzoni building (Figure 1a) which in 2013 presented a tilt of  $2.17^\circ$  and plumb displacements ( $\delta$ ) of 2.10 m. The Tower of Pisa (Figure 1b) and the Bad Frankenhausen tower (Figure 1c) are the most famous cases worldwide, which showed displacements of 4.03 and 4.60 m, respectively. In the tower of Pisa (Italy), the inclination was caused by the fluctuating water level that strongly influences the movement of the ground. While in the Bad Frankenhausen tower (Germany), the tilt was caused by the salt-bearing rock layers in contact with groundwater.

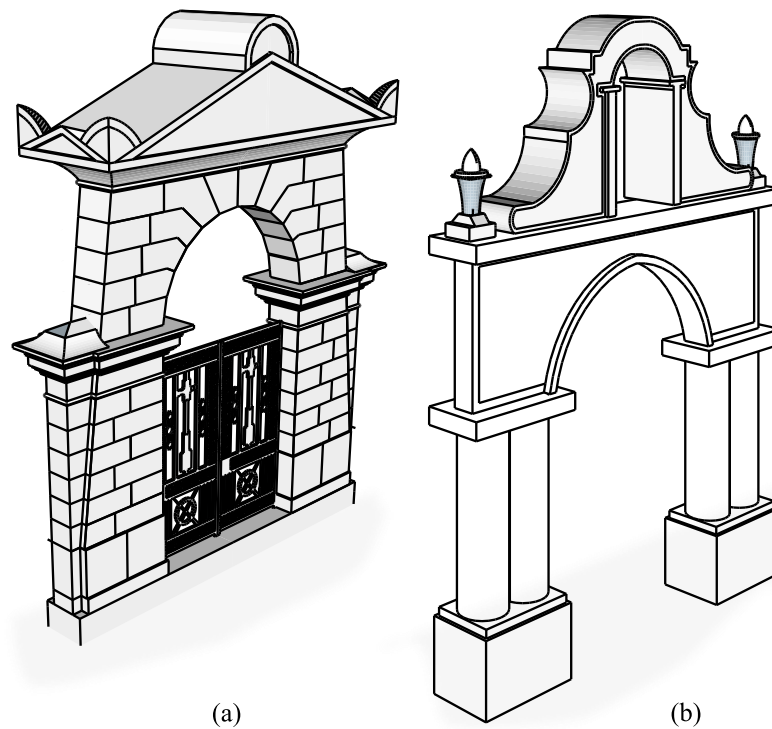
Figure 3. Illustration of types of entrance gate frames found in the Soledad Cemetery: (a) built with stone blocks and (b) built with reinforced concrete.

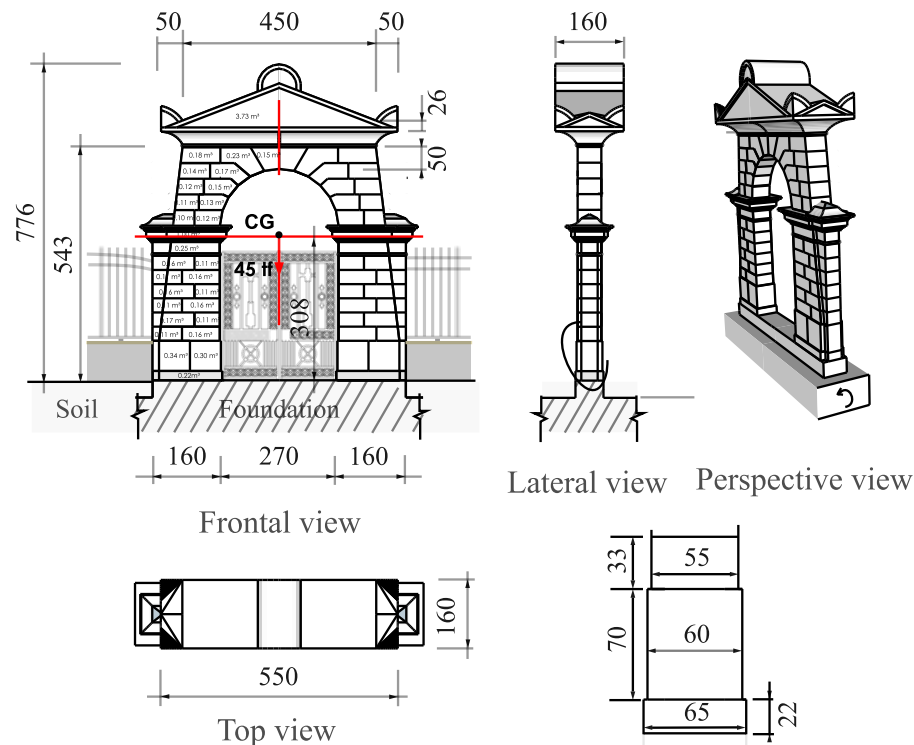
Figure 5. Gate frame dimensions (unit: cm)

wrought iron gate produced by the English firm Singlehurts & Muller Co., as illustrated in Figure 5. The non-monolithic structure is composed of an assemblage of carved stone blocks. The height, length, and width were  $\sim 8.0 \times 6.0 \times 0.65$  meters, respectively, and the self-weight was estimated at 45 tf.

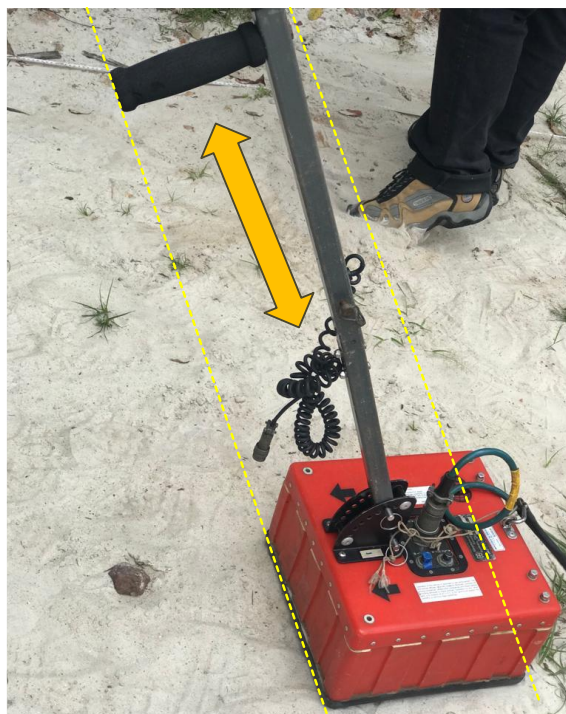
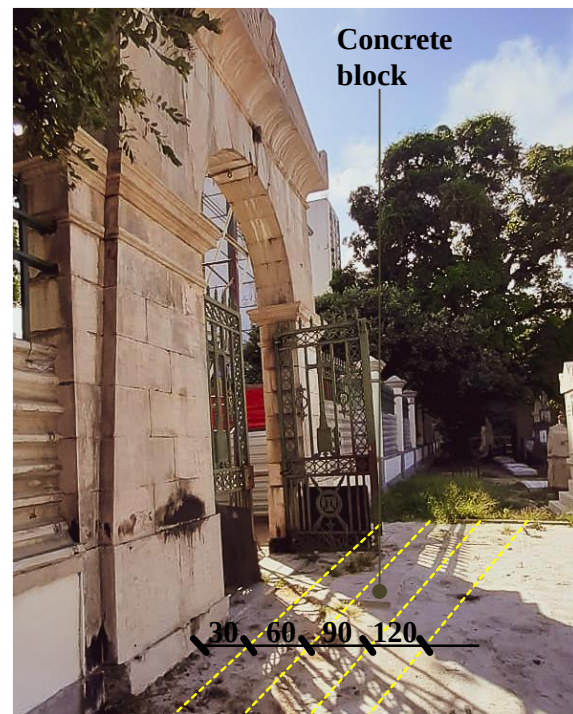
Figure 6. (a) GPR used and (b) Positions investigated.

It was noted that the signals were intense up to the 60 cm position, while at the 90 cm position, the presence of the signal was identified only in the middle, this was due to the existence of a concrete block extending up to this position, as can be seen in Figure 6b, whereas the radagram at the 120 cm position did not identify any stone in this position. For validation of the mapping results, 20 cm drills were made on both sides parallel to the structure, as shown in figures 8a and 8b, thus, the extension of the foundation block was proven at 80 cm position and the backfill layer at 40 cm.

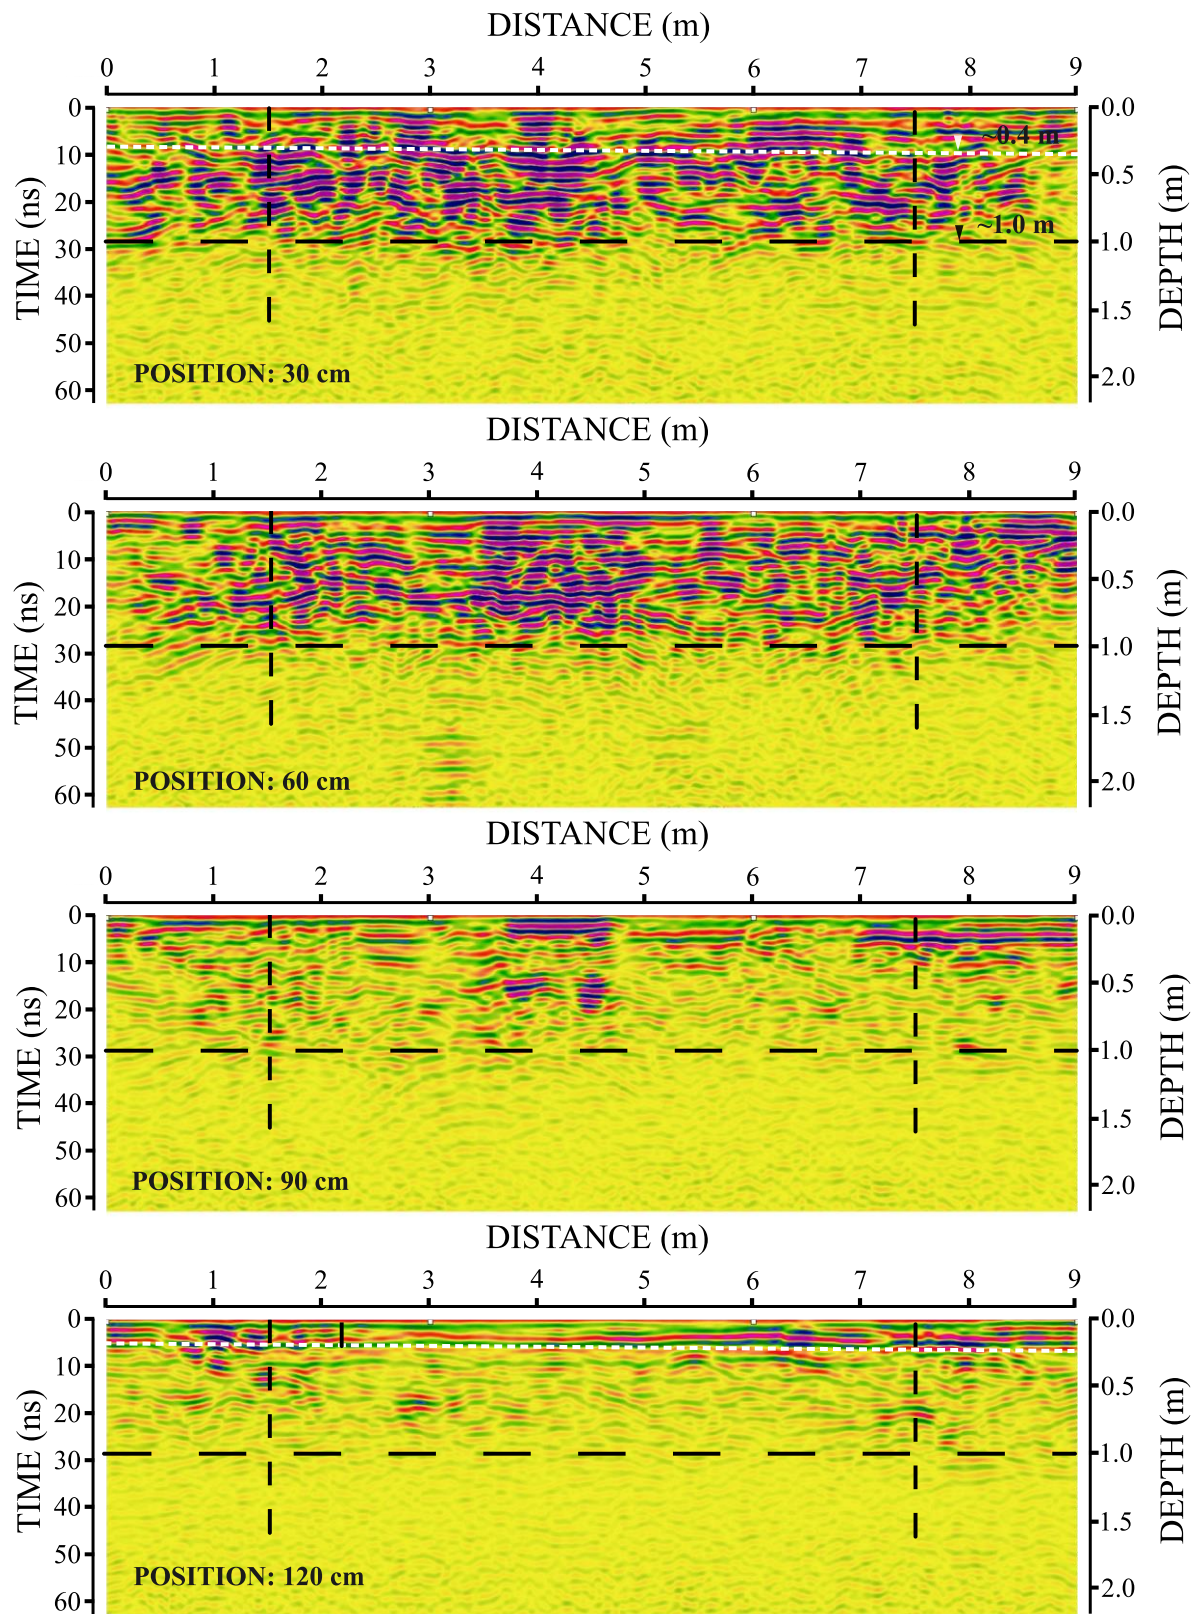
Figure 7. Foundation Radagram.

According to the report of the drilling of the STP (Surface-Treating Pressure), the soil profile is of yellow sandy silt type with average compactness up to 9 m depth, presented in Table 1. The mapping of the foundation was performed with the GPR, also known as Georadar. GPR is an electromagnetic geophysical method that uses pulses of radio waves at certain frequencies to map and identify underground structures. This practical methodology detects the depth, composition, and presence of objects or anomalies in the subsoil, avoiding the necessity of excavations. It is considered a non-intrusive and low-cost method of surveying the subsurface and is used in various applications for the preservation of buildings with historical value, as well as in archaeological investigations (Hussain and Akhtar, 2017). Table 2 presents the characteristics of the GPR equipment used, as shown in Figure 6a, which has a 500 MHz antenna frequency and works in the time domain in data post-processing. The detections were made in the proximities parallel to the structure at 30, 60, 90, and 120 cm positions, according to Figure 6b. According to the processed radagrams presented in Figure 7, it was possible to observe different GPR signal responses in the soil along the structure, such as longitudinal discontinuities in the fill materials, indicating the existence of inhomogeneities in a single material, the irregular shapes and sizes of the reflection images generated revealed the existence of stones, and the different behavior of the strongest signal may be an indication of the presence of cementitious material, in other words, cyclopic concrete was used in the shallow foundation, as shown by the signal intensity at a depth of up to  $\sim 1.0$  m and along the parallel positions to the structure.

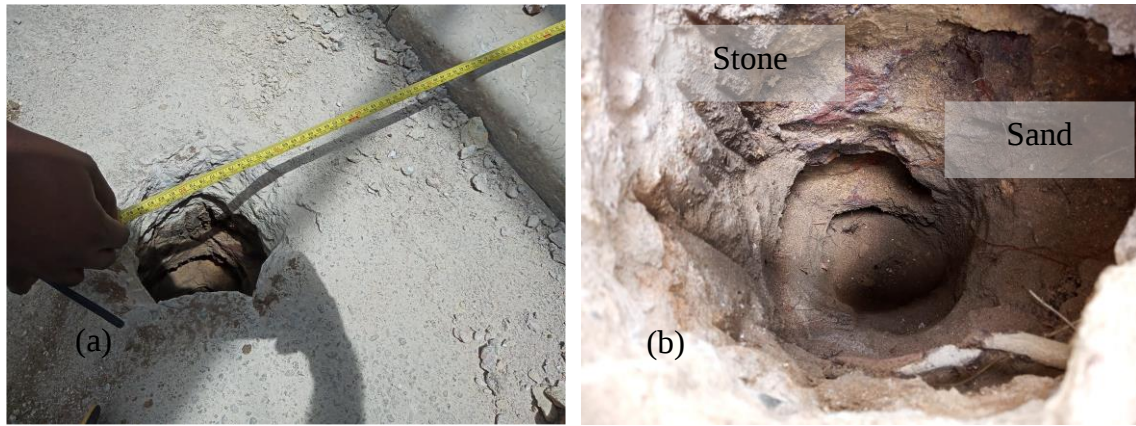
Figure 8. Checking the extension of the foundation block: (a) from outside the cemetery and (b) from inside the cemetery.

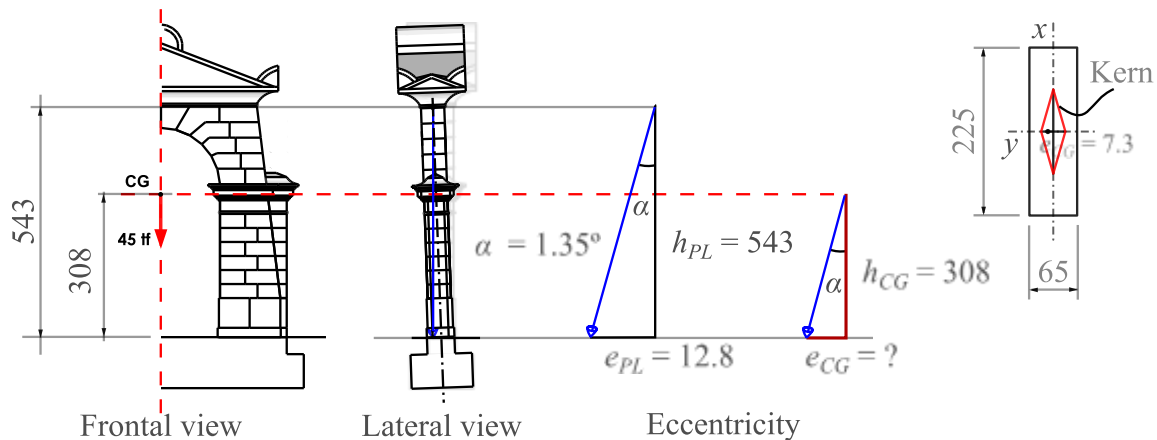
Figure 9. Assuming eccentricity by plumb line method. (unit: cm)

According to Spyarakos and Nikolettos (2005), overturning occurs by rotation around the center of gravity (CG). However, a tilt of  $1.35^\circ$  was observed, probably due to settlement over time, traffic, or the movement of soil during excavation for the asphaltting of Serzedelo Street, generating an eccentricity of 7.26 cm in the direction of the y-axis. In the direction of the x-axis, the structure did not exhibit any inclination. The Plumb line method was adopted for measuring the eccentricity, as illustrated in Figure 9. The results were computed using equations 1 and 2.

$$\frac{e_{PL}}{h_{PL}} = \frac{e_{CG}}{h_{CG}} \Rightarrow e_{CG} = h_{CG} \cdot \frac{e_{PL}}{h_{PL}} \Rightarrow e_{CG} = h_{CG} \cdot \tan(\alpha) \quad (1)$$

$$e_{CG} = 3.08\text{m} \cdot \tan(1.35^\circ) = 0.0726\text{m} \quad (2)$$

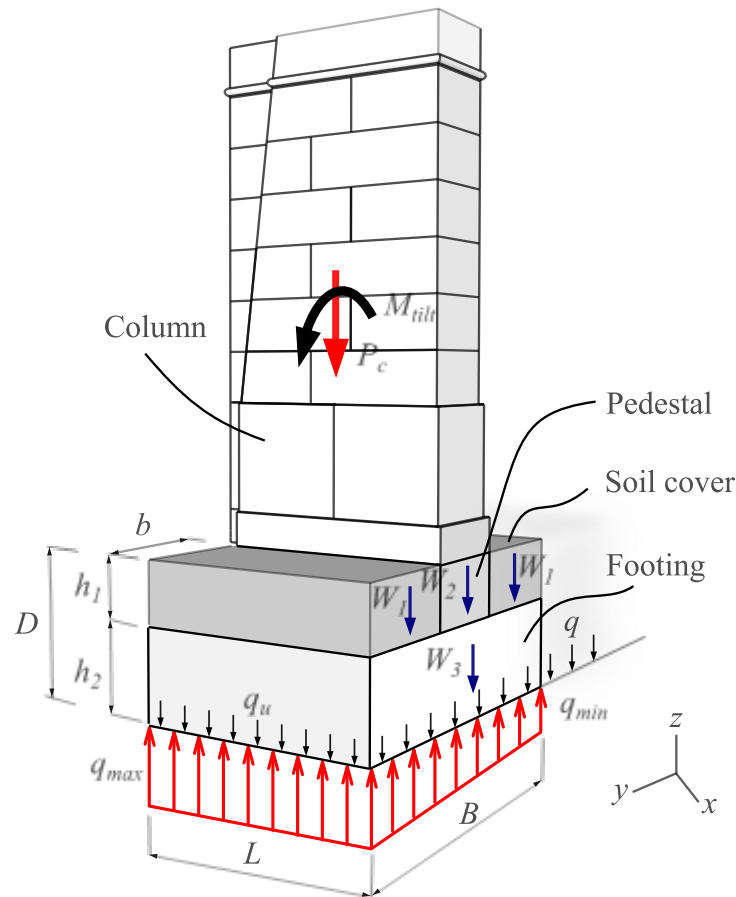
Figure 10. Assumed forces acting on stabilizing of column foundation.

Table 4 presents the parameters used to calculate the forces acting on the column (self-weight,  $P_c$ ), the overburden (soil cover or backfill,  $W_1$ ), and the foundation ( $W_2$  and  $W_3$ ), defined respectively by Equations 11, 12, 13, and 14, as shown in Figure 10. The total vertical load ( $P_V$ ) was calculated according to Equation 14 and the moment due to the centroid ( $M_{tilt}$ ) of the column was calculated according to Equation 15.

$$P_V = P_c + W_3 + W_2 + 2 \cdot W_1 = 22.50 + 5.77 + 1.11 + (2 \cdot 0.92) = 31.22 \text{tf} \quad (14)$$

$$M_{tilt} = P_c \cdot e_{CG} = 22.50 \cdot 0.0726 = 1.63 \text{tf} \cdot \text{m} \quad (15)$$
