Evaluation of the carbonated front in concrete samples subjected to non-regular wetting-air drying cycles.

Keywords: reinforced concrete; carbonation; corrosion; durability.

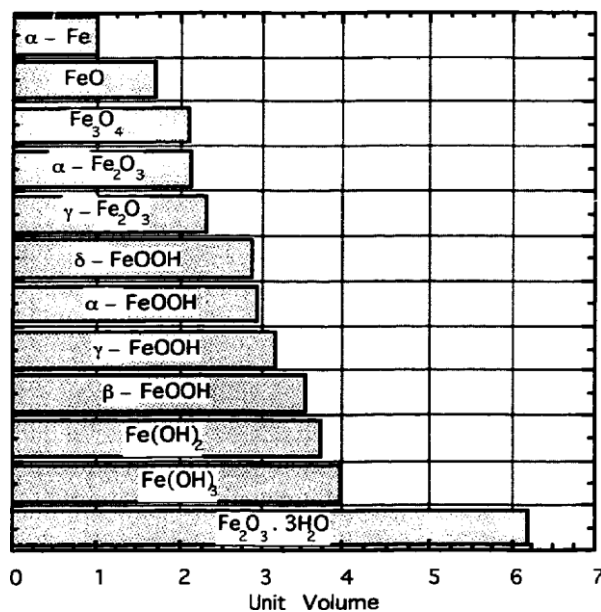
Figure 1. Products resulting from the corrosion of iron (Marcotte, 2001).

The degradation of reinforced concrete structures associated with reinforcement corrosion mechanisms is very significant. This results in high costs for the repair of the affected structures. Studies carried out in the region, for example in Argentina (Di Maio et al., 2009) and Brazil (Dal Molin, 1988), have established a high incidence of structural degradation associated with corrosion over other deterioration mechanisms. But by nature, concrete has a high pH, which allows under this condition to passivate the embedded reinforcements, thus protecting them from the development of corrosive processes. The advance of the carbonation front (due to CO₂ penetration) results in the loss of alkalinity in the concrete, thus producing the depassivation of the reinforcements and allowing the possible development of corrosion in the steel, which leads to concrete degradation. This situation is due to the fact that when a steel bar corrodes, the resulting volume is approximately six times that of the iron it replaces when the bar is not corroded (Marcotte, 2001). This causes high tensile stresses to occur at the reinforcement/concrete interface, which leads, among other things, to cracking and loss of the concrete cover. Figure 1 shows the products resulting from the corrosion of iron.

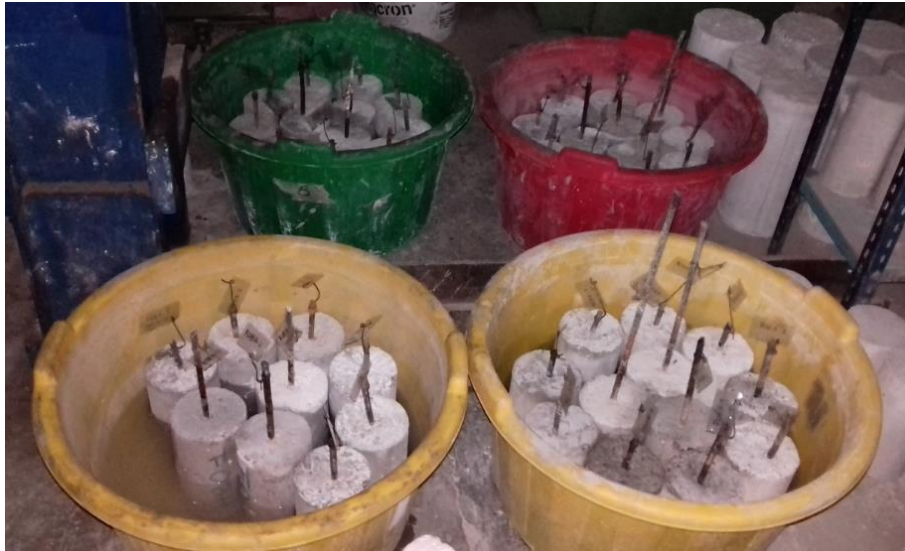
Figure 2. Exposure condition of the specimens to be evaluated.

The qualitative evaluation of the carbonate front was carried out on a group of 12 samples. Each sample consisted of three specimens, which were kept for approximately six years in a particular environmental exposure condition. This condition involved subjecting the specimens to alternating cycles of submergence, partial submergence, and air-drying (Figure 2). The time of each exposure cycle was not established as a study variable and therefore not controlled, but it was the same for each sample. It should be noted that the water level in the containers containing the samples was renewed approximately every two months.

Specimens of 100 mm diameter by 200 mm height were used (IRAM 1534, 2004). The materials reported in the preparation of the samples were pozzolanic Portland cement (CPP-40) and fillerized Portland cement (CPF-40), both complying with the respective standard (IRAM 50000, 2000); rolled natural aggregates of maximum size 19 mm; and inorganic waterproofing additive identified in its technical sheet as a water-repellent additive, incorporated to the fresh mix in a dose corresponding to 10% of the mixing water. This additive presents a suspension of colloidal silicates in a viscous liquid aqueous emulsion, pale yellow in color, which is distributed within the cementitious matrix, blocking its capillaries and thus obtaining the waterproofing effect. On the other hand, these silicates react with the portlandite released by the cement, forming insoluble compounds that also block pores and capillaries.

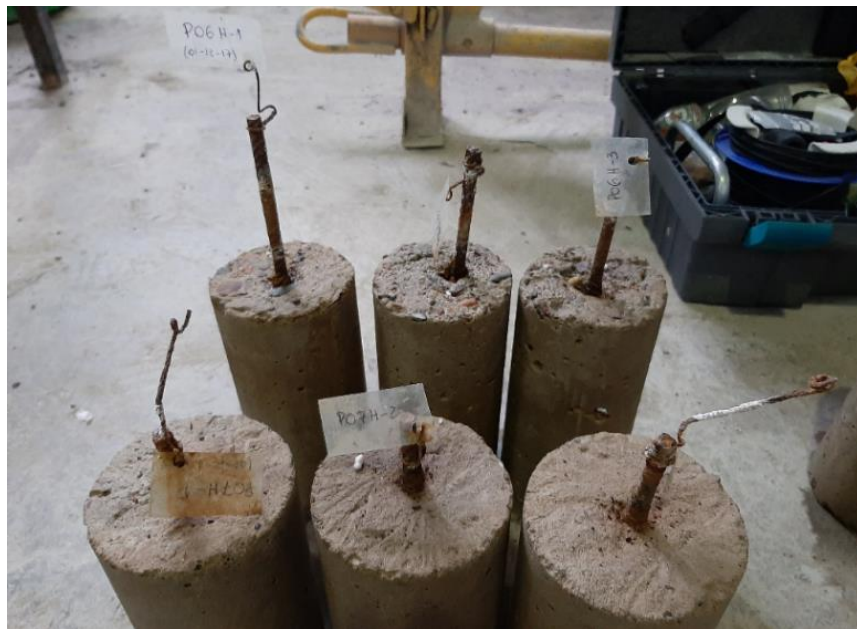
As for the bar embedded in the upper face of the specimens (Figure 3), it corresponded to an 8 mm diameter rod, steel ADN 420 (IRAM/IAS U 500-528, 2022), and with a depth embedded in the concrete of approximately 100 mm.

Figure 3. Bar embedded in the upper face of the specimens.

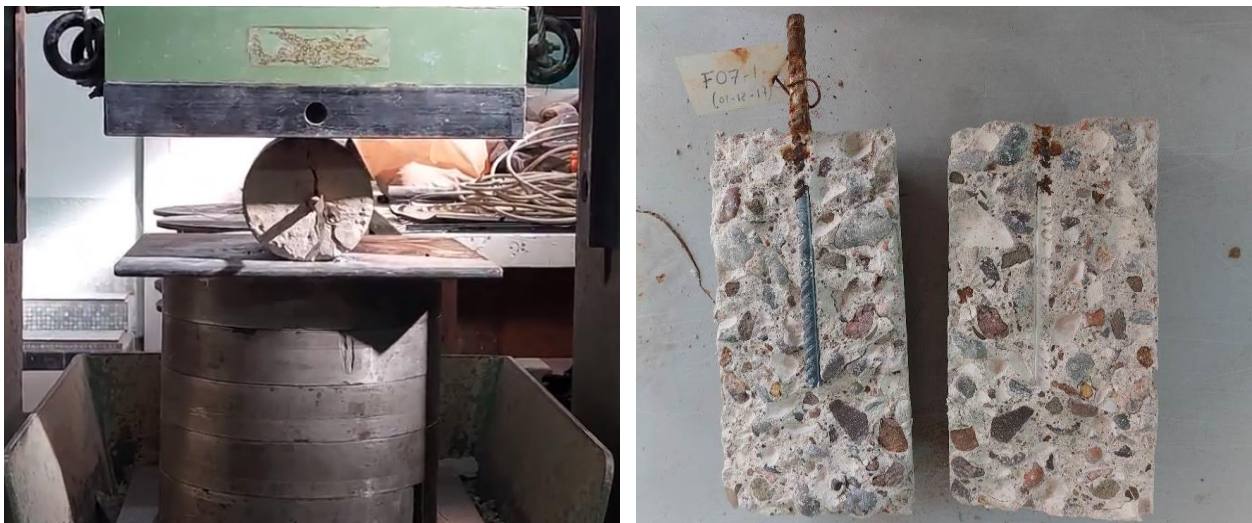
For the evaluation of the carbonate front, the specimens were previously subjected to the diametral compression tensile test (IRAM 1658, 1995) (Figure 4). This made it possible to obtain two halves, and thus, two internal surfaces for evaluation. Although the specimens had an embedded bar, the breaking strain was inferred from this test.

Figure 4. Left) Diametral compression tensile test. Right) Halves obtained from the test.

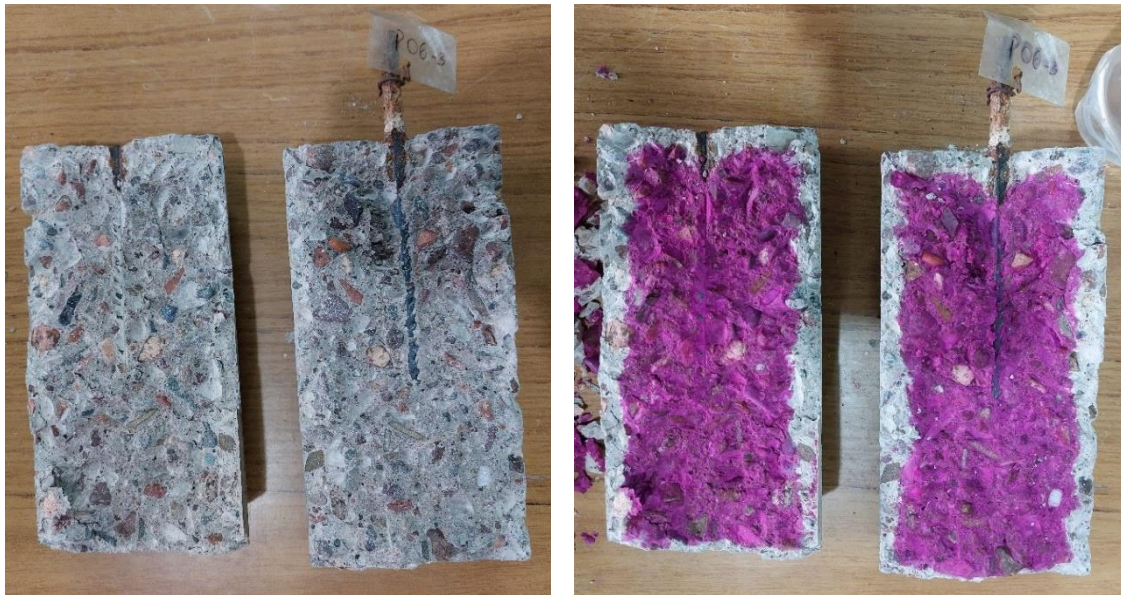
A phenolphthalein solution was applied on each internal surface obtained, thus allowing to evaluate the progress of the carbonation front. Figure 5 shows the internal surfaces of one of the samples before and after the carbonation test.

Figure 5. Left) Internal surfaces before the test. Right) After the test.

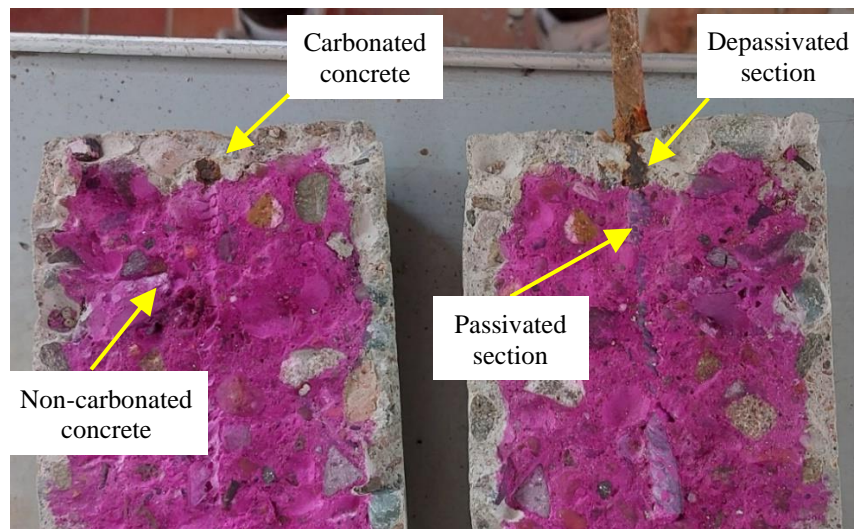
As expected, part of the reinforcement embedded in the specimen was depassivated due to the advance of the carbonation front. In addition, the exposure conditions to which the specimens were exposed over 6 years led to the initiation and subsequent propagation of the corrosive process in the depassivated section of the bar. Figure 6 shows one of the cases evaluated, where the penetration reached by the carbonated front is observed, and with it, the clear delimitation between the corroded and non-corroded bar section.

Figure 6. Advance of the carbonation front. Passivated and depassivated bar section.

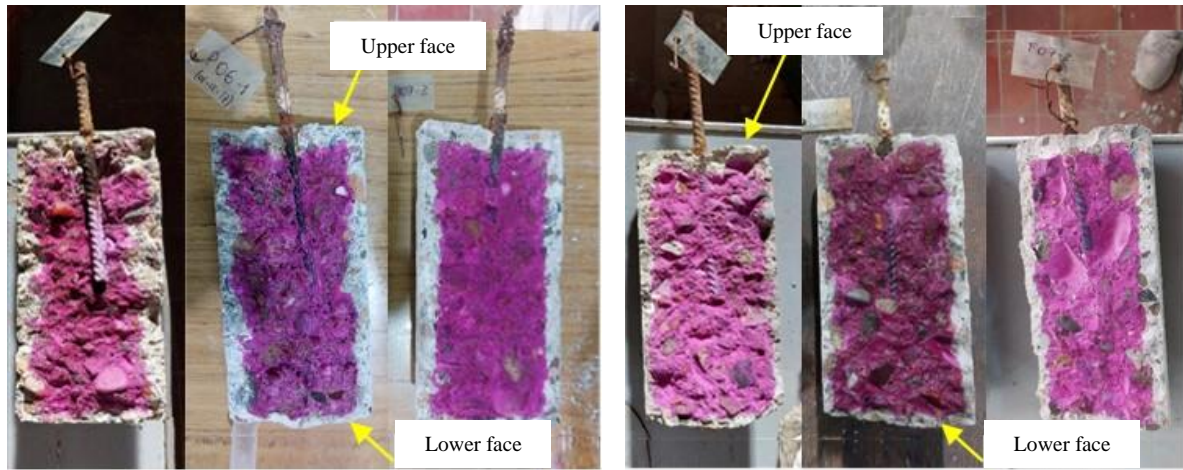
or partially saturated pore conditions. Figure 7 shows the differences observed in the advance of the carbonation front between the lower and upper faces, for the specimens made with pozzolanic cement (P) and with fillerized cement (F), and without water-repellent additive.

Figure 7. Advance of the carbonate front. Left) Samples “P-0x”. Right) Samples “F-0x”.

The exposure conditions to which the specimens were subjected over time caused different zones of the specimens to be under different microenvironments. While the lower face was submerged most of the time, the upper face was exposed to the open air most of the time. Therefore, the lower face was the one that presented longer cycles of saturated pores, unlike what happened with the upper face. These particular conditions, it is understood, caused the advance of the carbonate front on the lower face to develop at a slower rate. This was due to the greater difficulty of CO_2 dissolution in the saturated pore solution in this zone of the specimens. On the contrary, this penetration rate was higher on the upper face because this zone presented the longest cycles in dry

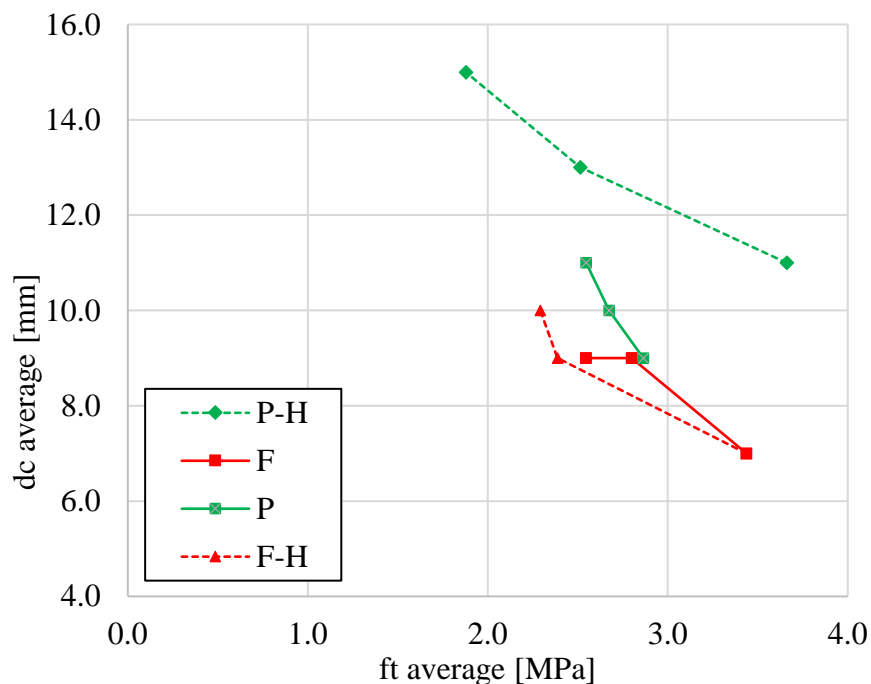
Figure 8 shows, for each of the study samples, the evolution of the carbonate front advance as a function of the tensile strength (ft). It is observed that the higher the strength values obtained in the tests, the lower the advance of the carbonate front (dc).

Figure 8. Tensile rupture stress vs. carbonate front advancement on lower face.

For similar levels of tensile breaking strain, the carbonate front breakthrough was higher in those samples made with pozzolanic cement. This could be due to the lower alkaline reserve available due to the consumption of portlandite resulting from the pozzolanic reaction (de Medeiros et al., 2017). Regarding the effect of the hydrophobic additive, the incorporation of the additive resulted in a slight increase of the carbonate front. In this case, it could correspond to the fact that such additives are hydrophobic materials based on salts of fatty acids, calcium, ammonium, etc., which react with portlandite (Ramachandran, 1996), again decreasing the alkaline reserve.
