## Restoration of the facade of the church of San Pedro Apostol in Agost, Spain

This work describes the studies and the intervention carried out for the restoration of the facade of San Pedro Apostol in the parish church of Agost. This facade was made at the end of the 18th century in limestone. After an initial inspection and graphic survey of the facade, the lesions, their origin, and the solution to them were identified by using advanced restoration techniques. The stone elements damaged or destroyed by the passage of time are composed of calcite, dolomite and silica, with plaster joints, and have been reconstructed either through the use of new elements or, for the most part, through systems of recovery of the initial volume with the use of a light core of polystyrene, lime mortars, expanded clay, fiberglass and carbon together with infiltrations of resins in the disintegrated areas. After a delicate intervention process using innovative techniques, the facade was completed in June 2023.

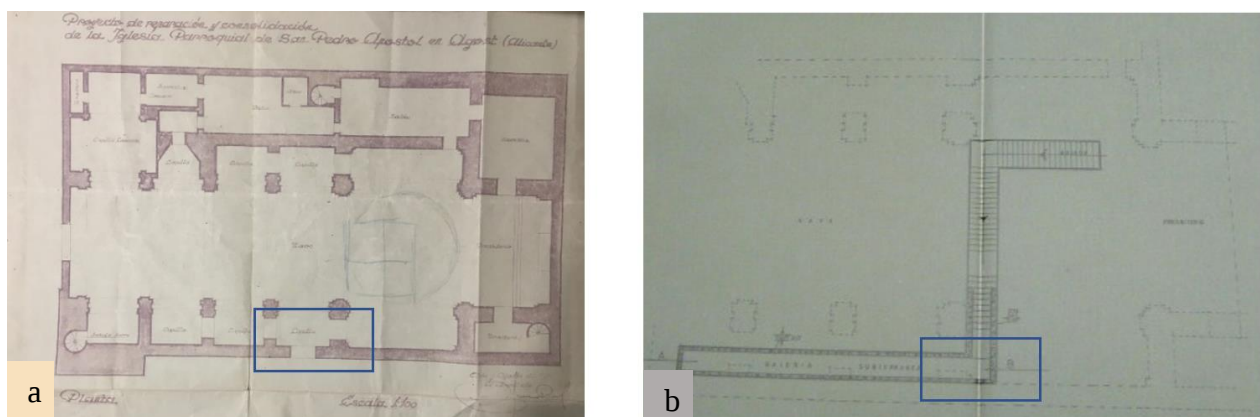
The collection of documentary data has been carried out especially in the parish archive and the Serrano y Valderrama architecture office in Elche, where the studies and project of the architect Antonio Serrano Peral, who worked on the church in the mid-20th century and was the author of the drawing in Figure 3, are kept. Mainly cracks in the interior and facades of the building caused by the excavations carried out inside the church. The damage to the doorway is not described, although the wall that supports it has a crack next to it on the right-hand side, probably due to the same cause as the cracks in the interior. Figure 3b) shows that there is a hollow area next to the facade containing the doorway, which corroborates the origin of the fracture.

Figure 3. a) General drawing of the church made for the intervention carried out in the 1960s by Antonio Serrano Peral. b) Detail of the staircase and excavated area inside the church. The location of the doorway under study is indicated. Source: private archive of the Serrano Peral family.

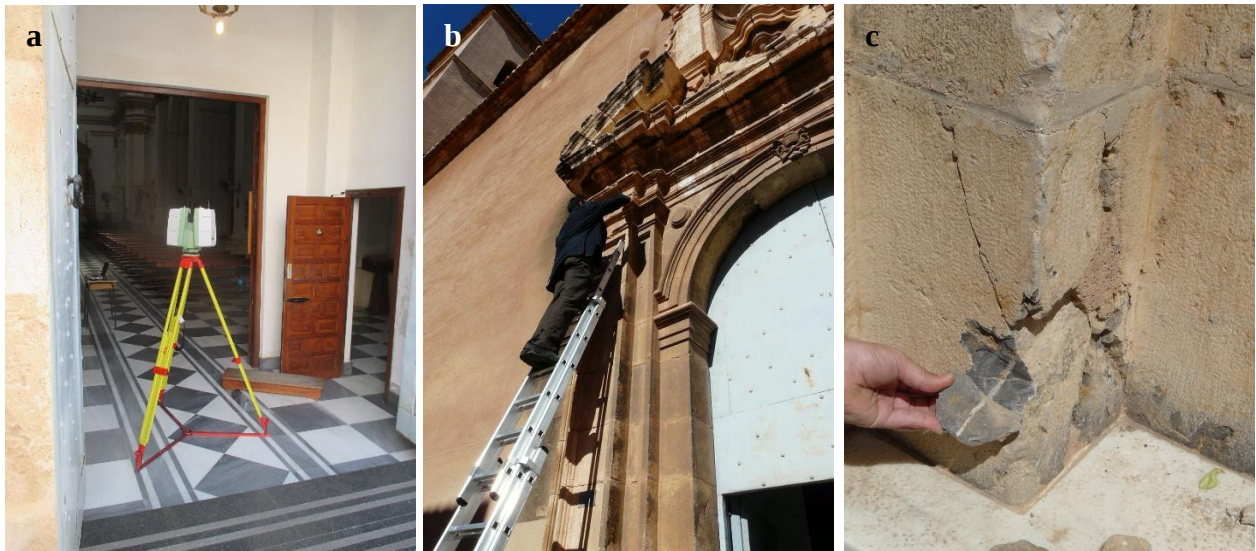
The in-situ data collection was carried out on the basis of the point cloud obtained with a laser scanner. Samples were taken without degrading the doorway, following the recommendations of experts such as Esbert and Losada (2003). Small fragments of beige calcarenite stone deposited on the cornices and a loose flake of the black stone at the base were taken (Figure 4).

Figure 4. Different aspects of data and sample collection. a) Detail of geometric recording with laser scanner. b) Collection of samples of loose fragments on the cornice. c) Black stone flake in lower corner for observation.

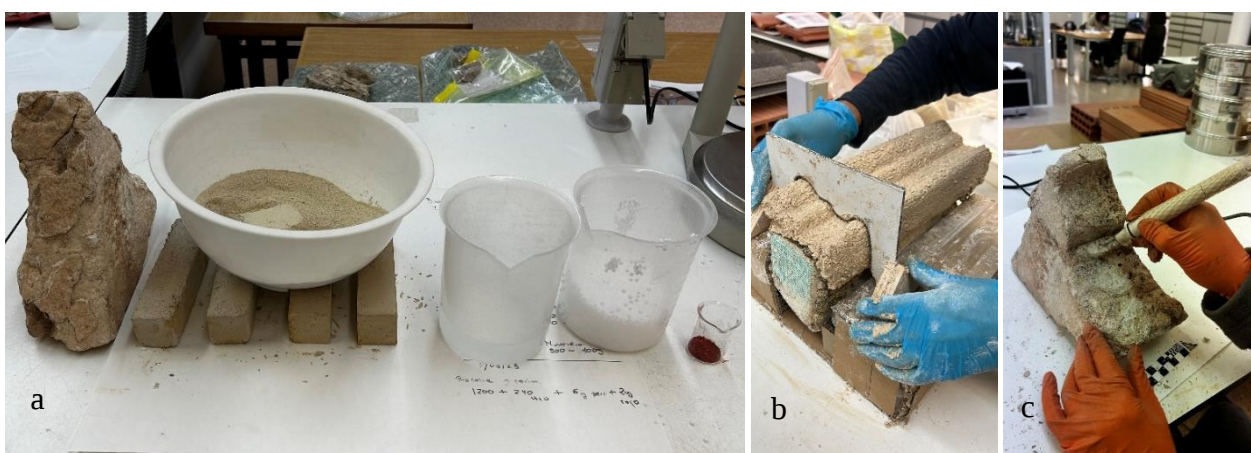
A fragment that had become detached from the facade was taken to the Architectural Constructions laboratory of the University of Alicante and was used as the basis for the study of density and colour, as well as for testing cleaning techniques. Figure 10 shows some of the tasks carried out in the laboratory.

Figure 10. Different aspects of the previous studies carried out for the restoration of the doorway. a) Components prepared to make test specimens for subsequent study together with the fragment of the cornice of the doorway (bio-lime, water, eps beads and natural pigments). b) Detail of the test carried out in the reintegration laboratory with a light polystyrene core and exterior lime mortar. c) Detail of a cleaning test using ultrasound.
