Pathological manifestations in a prestressed concrete flat slab building - a case study: part II - structure reinforcement.

This study presents the recovery and structural reinforcement work conducted on a commercial building and is complementary to the study “Pathological Manifestations in a Prestressed Concrete Flat Slab Building - A Case Study: Part I - Structural Analysis.”

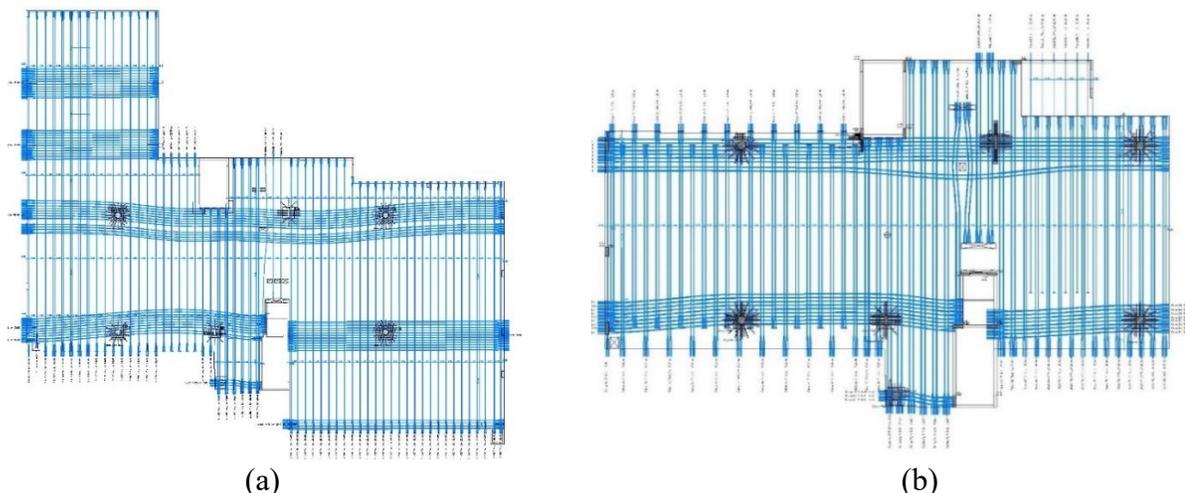
Figure 2. Unbonded tendon distribution: (a) 2nd floor and (b) 3rd floor slabs.

Unbonded tendons were more concentrated in one direction and more sparsely distributed in the orthogonal as shown in Figure 2(a) for the 2nd floor. A similar distribution to the 2nd floor was also used in the ground floor slab. In comparison, Figure 2(b) shows the tendon distribution on the 3rd floor which was similar to the distribution used on the top floor.

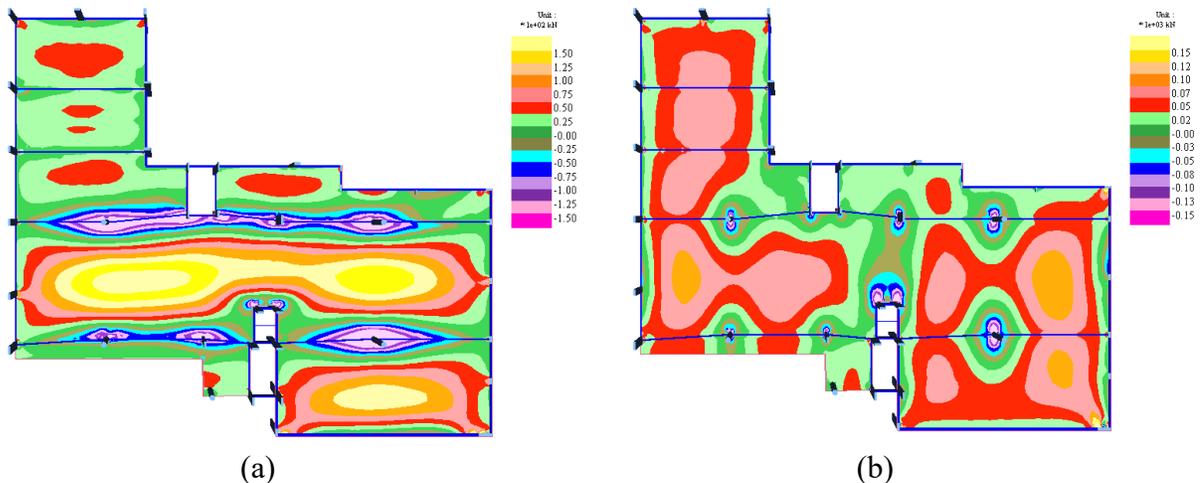
Figure 15. Isocontours of bending moments on the 2nd floor slab ($\times 10^2$ kN.m/m) (a) in the y-direction (M_{xx}) and (b) x-direction (M_{yy}) with respect to the orientation of the figure.

Results showed that metallic reinforcements and external prestressing reduced significantly slab bending moments and decreased vertical displacements (arrows) to values within tolerances recommended by standard NBR 6118 (ABNT, 2014).

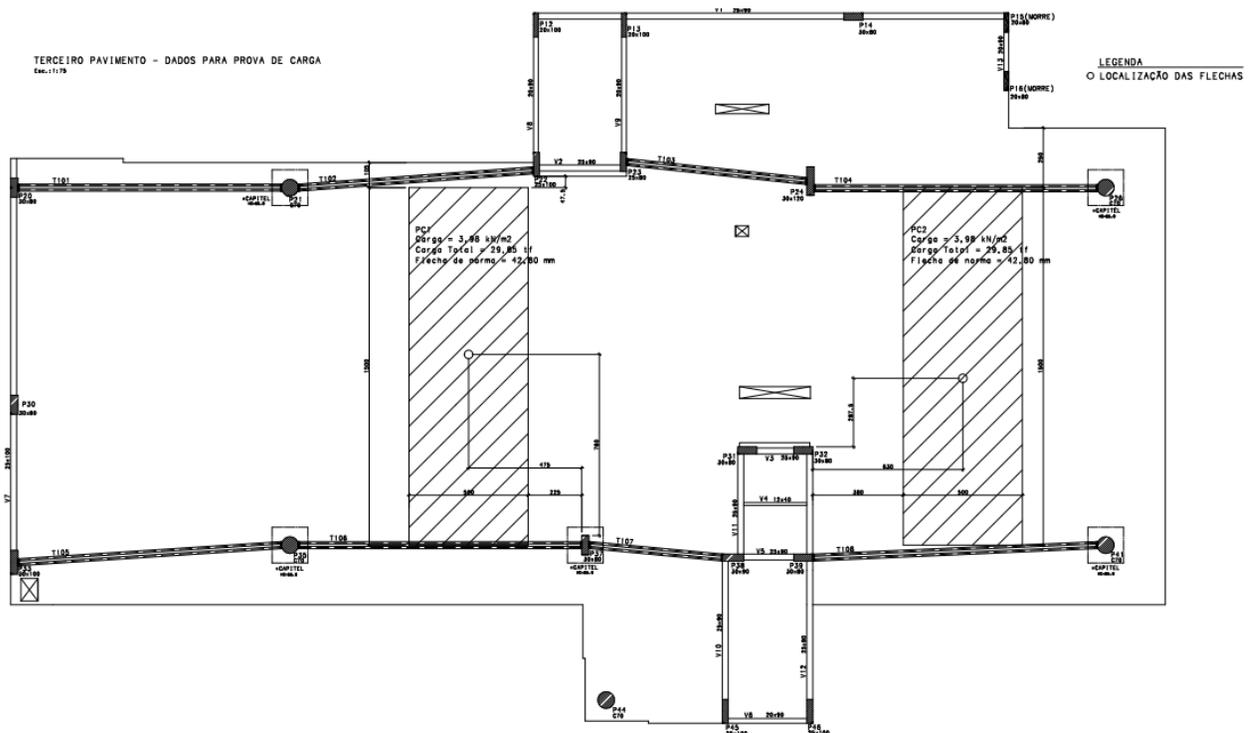
Figure 18. Load plans for 3rd floor slab.

Results from the load tests on the ground floor with new column and composite beam reinforcements were very favorable. Deformations were measured to be around 20 % of the calculations, well below predictions and limits set by standards. On floors with steel reinforcement and external prestressed cables, deflection arrows were measured to be 30 % of predicted values. In the top cover slab of the water reservoir, which was reinforced only with carbon fiber overlays and no metallic or external prestressed cables, deformations were measured to be 90 % of predicted values.
