## The importance of underpaint corrosion caused by damage to paint on steel structures

The impact of varying the dry paint film thickness (DFT) on the underpaint corrosion of steel plates obtained from the floor of an offshore oil platform is evaluated. The specimens were all prepared using the same material and paint scheme, and the DFT and exposure conditions in a salt spray chamber were varied and compared with the results obtained in a real situation. The results indicated that corrosion initiated at sites where the paint was damaged, may be more important than corrosion through the undamaged paint due to permeation, even in cases where the DFT is thin. In specimens whose substrates were previously damaged, there were pathological manifestations of osmotic blistering. The underpaint corrosion that occurred after the paint was damaged in the field occurred at an intensity like that observed for the tested specimens.

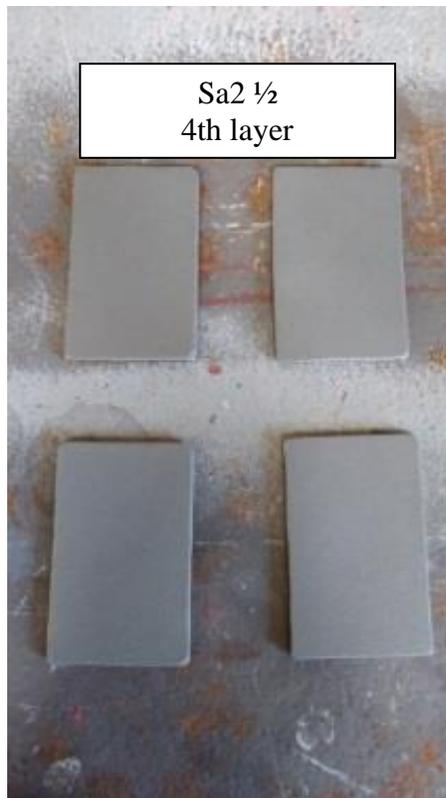
Figure 1 Plates prepared with a Sa2½ abrasive jet (Ribeiro Filho, 2018)

Six groups of specimens were prepared, where groups 1 to 5 were composed of four specimens each (named A, B, C and D), and group 6 was composed of only two specimens (named A and B). All specimens were previously washed with clean water. The specimens from groups 1 and 2 were previously subjected to St3 and Sa2½ surface preparation methods, respectively, according to standard ISO 8501-1 (ISO, 2007) and standard NBR 10443 (ABNT, 2008), respectively, and were then subjected to a small thickness coating system. Groups 3 and 4 were subjected to St3 and Sa2½ surface preparation methods, respectively, and a complete paint system was used to apply the paint to the atmospheric zone<sup>1</sup> (Table 1); according to the painting procedure used for the project, which expects a DFT between 445 µm and 600 µm, the DFT was measured for each layer. Prior to painting, the roughness of all specimens was measured after the Sa2½ preparation method was performed to verify if the DFT requirement of 50 µm to 100 µm, as predicted in the painting procedure of the project, was met (Figure 2).

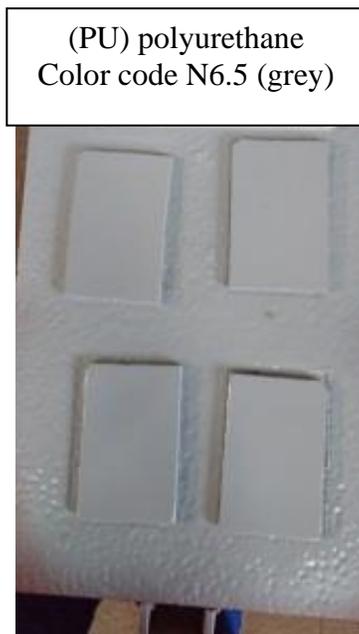
Figure 3. Finishing the paint (Ribeiro Filho, 2018).

The surfaces of the specimens that received the St3 treatment were treated according to the standard ISO 8501-1 (ISO, 2007); the surfaces of the specimens that received the Sa2½ treatment were treated according to the standard NBR 15239 (ABNT, 2005). After each paint coating, the DFT was measured according to the standard NBR 10443 (ABNT, 2008), and the results of the preparation method are presented in Table 2. Figures 3 and 4 show images of the paint and the DFT measurement.

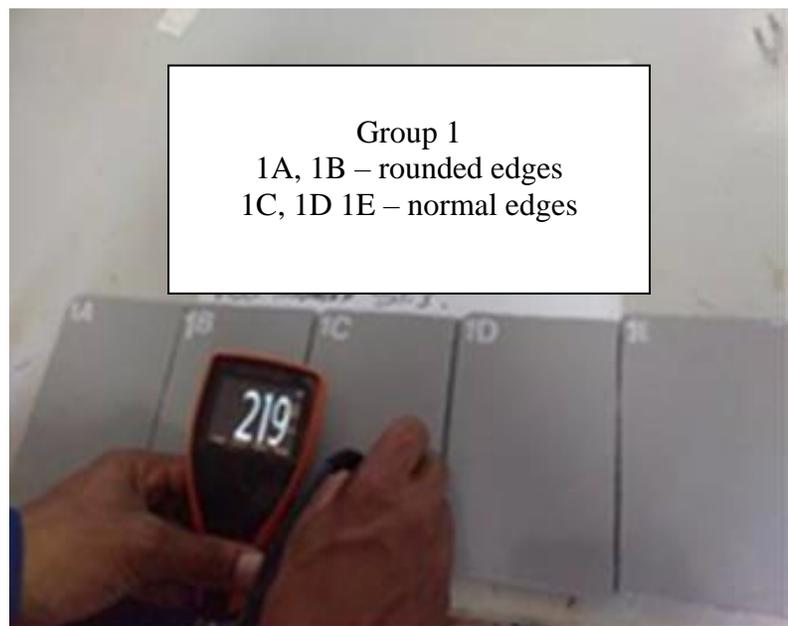
Figure 4. Measuring the total DFT (Ribeiro Filho, 2018).

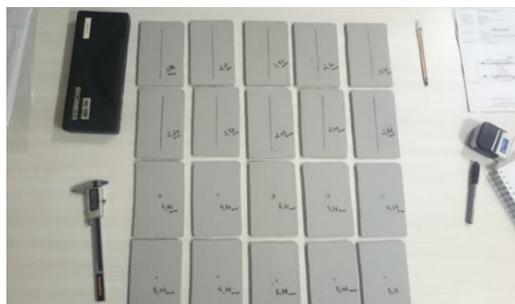
Figure 5. Specimens with experimentally damaged paint (Ribeiro Filho, 2018).

After painting, the paint layers were carved to simulate experimental damage/defects in the paint applied to the specimens from all groups; some of the carvings were longitudinal, and some were puncture carvings with 5 mm diameters, as shown in Figure 5.

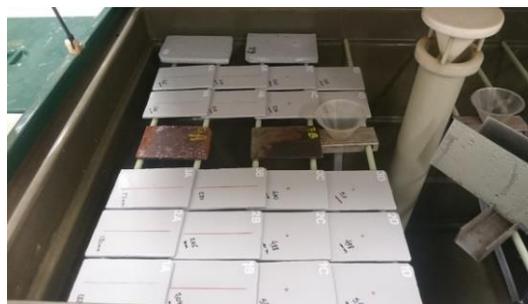
Figure 6. Specimens in the salt chamber before exposure to the mist (Ribeiro Filho, 2018).

All specimens were subjected to a salt spray chamber (Figure 6) with a 5% sodium chloride (NaCl) saline mist, in which the mist was uniformly sprayed at a controlled temperature, according to ISO 9227 (ISO, 2012), NBR-8094 (ABNT, 1983) and B117-16 (ASTM, 2001). The temperature was maintained within the interval of  $35 \pm 2^\circ\text{C}$ , and the specimens remained in the salt spray chamber for 1550 h.

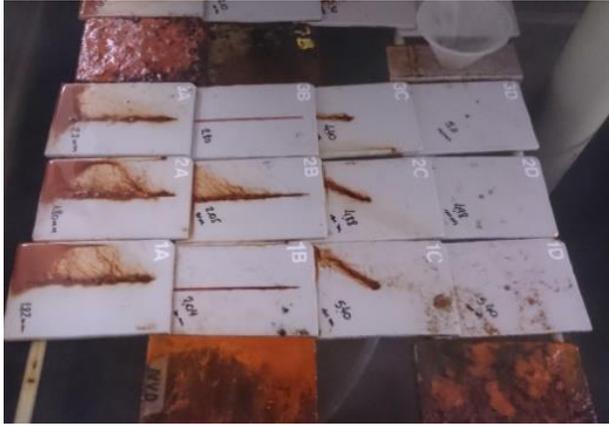
Figure 7. Specimens after the 1550 h exposure (Ribeiro Filho, 2018).

After removing the specimens from the saline chamber (Figure 7), the specimens were washed with clean running water at room temperature ( $<40^\circ\text{C}$ ) to remove the salt deposits and immediately dried. Subsequently, the specimens were subjected to a penetrant liquid (PL) test, according to the standard NBR 9583 (ABNT, 1997), and the points of higher corrosion incidence were determined (Figures 8 and 9).

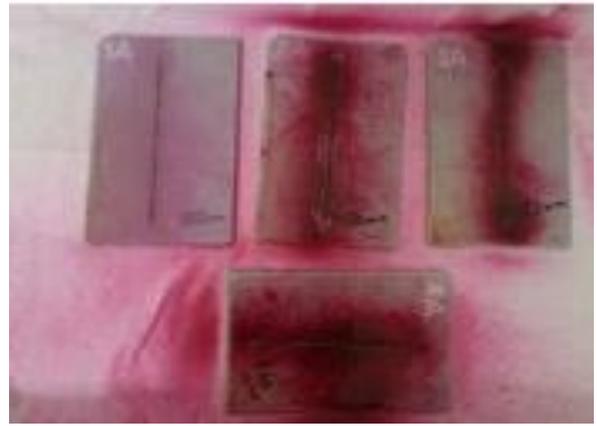
Figure 8. PL test awaiting development (Ribeiro Filho, 2018).

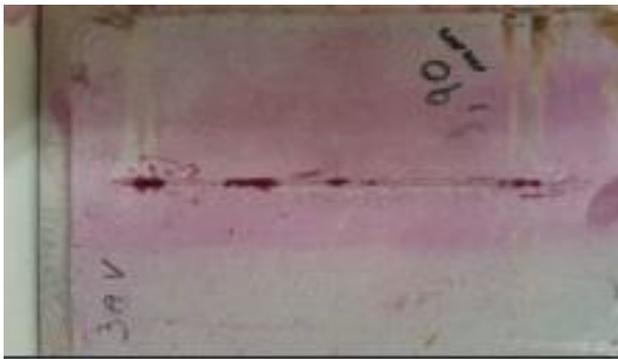
Figure 9. Specimen awaiting development (Ribeiro Filho, 2018).

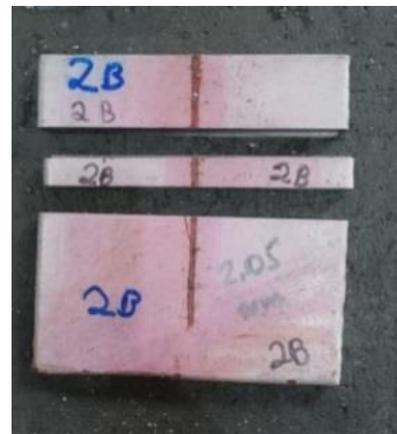
Figure 10. Specimen sectioned for microscopy observation (Ribeiro Filho, 2018).

These points were selected, and the specimens were cross-sectioned at those points (Figure 10). The cross-sections were observed under an LBM-044 microscope/stereoscope to measure the extent of the underpaint corrosion.

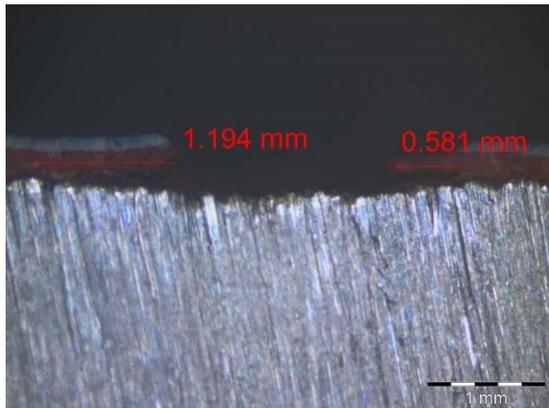
Figure 11. Underpaint corrosion measurement performed on specimen 2A (Ribeiro Filho, 2018).

For example, the observations made using a microscope, as illustrated in Figures 11 and 12, showed that in cases where the paint damage reached the substrate, corrosion occurred in both of the complete paint schemes (specimen 4A) and the thin-thickness scheme (specimen 2A), both of which used surface preparation treatment Sa2 $\frac{1}{2}$ , which offers greater adherence.

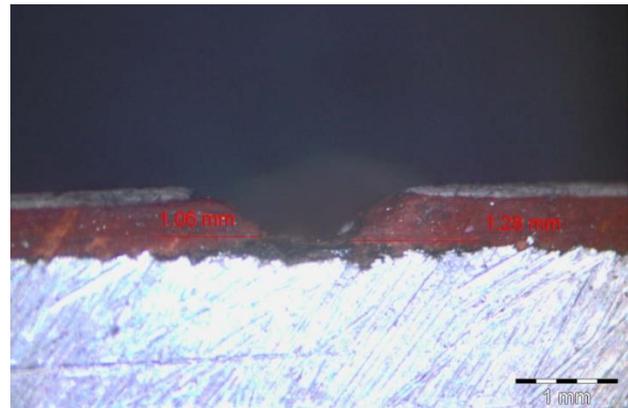
Figure 12. Underpaint corrosion measurement performed on specimen 4A (Ribeiro Filho 2018).

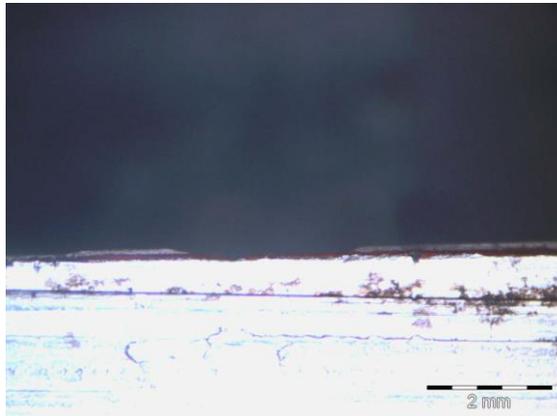
Figure 13. Underpaint corrosion measurement performed on specimen 1B (Ribeiro Filho, 2018).

In contrast, specimen 1B (Figure 13), which was prepared with a thin DFT and received previous paint damage but had the bottom paint layer preserved, exhibited corrosion after 1550 h. For similar cases, there was an exception only for specimens 2B, 4D and 5B, where reduced corrosion was observed, and this occurred only in one of the three measurements shown in bold in Table 3. It was therefore concluded that when the surface preparation treatment (the standard St3 or Sa2 $\frac{1}{2}$  treatment) is well performed, the electrolyte tends to access the substrate by the discontinuous paint if the paint exhibits a low permeability and porosity and receives a low peak exposure, as was the case for the specimens prepared for this study, and the resulting corrosion rate is similar for all the cases presented, even when the paint thicknesses are significantly different for the considered exposure time (1550 h).

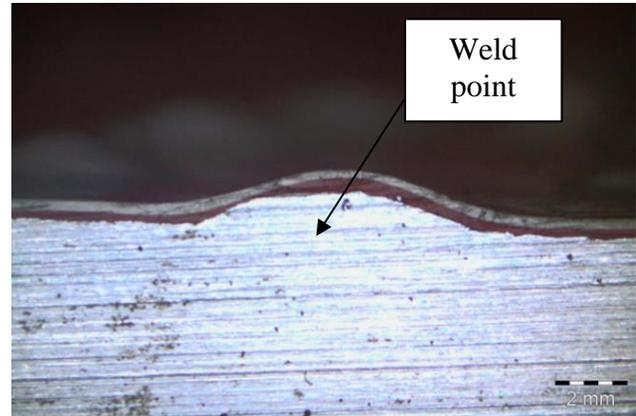
Figure 14. Cross section of specimen 6A (Ribeiro Filho, 2018).

Figure 14 shows the image of specimen 6A, in which the paint thickness on a welded point varied significantly. However, due to its integrity, the anticorrosion protection of the system was preserved, even with a film thickness of 283  $\mu\text{m}$ .

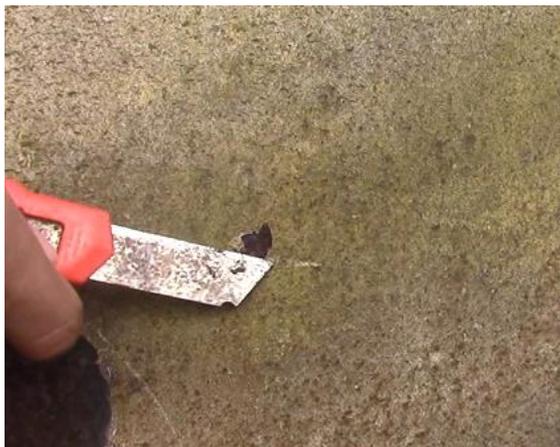
Figure 15. Mechanical damage to the field paint (Ribeiro Filho, 2018).

To compare the results obtained in the laboratory with those of a real platform situation, a surface with intact paint, except for a single isolated region of mechanical damage throughout the film, was identified during the field visit. By radially removing the paint from this central point, the limits of corrosion exhibited a circumferential configuration, denoting that equal corrosion occurred in all directions, which can be verified by the existence of sandblasting steel without corrosion, exhibiting a Sa2½ pattern from the limits of the corrosion edge, which reached a radius of 21 mm (Figures 15 and 16).

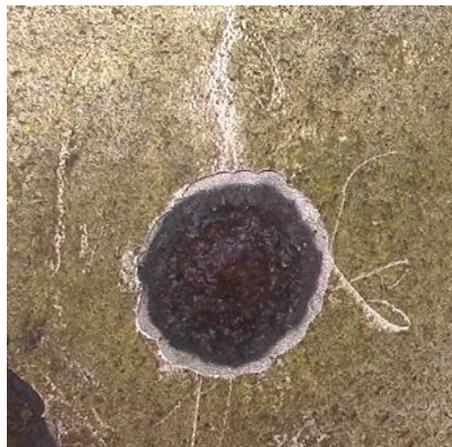
Figure 16. Edge of the corroded area and the area without corrosion (Ribeiro Filho, 2018).
