## Safety verification of fatigue of a reinforced concrete bridge according to ABNT NBR 6118 2014

In this case study, the fatigue security of a bridge designed in 1987 was examined considering the current Brazilian standard. A structural model was developed to determine and verify fatigue security in the most critical section considering the Brazilian Load Model and the literature's vehicle spectrum. According to the stress variation method, it concludes that the concrete submitted to compression meets the minimum criteria, but the steel section is not enough to resist shearing and flexural stresses. Pursuant to the Palmgren-Miner rule, the fatigue service life of the reinforcement's bars under flexural stress is 14,91 years. A more detailed structural analysis of the bridge and the vehicle spectrum is necessary to confirm these results.

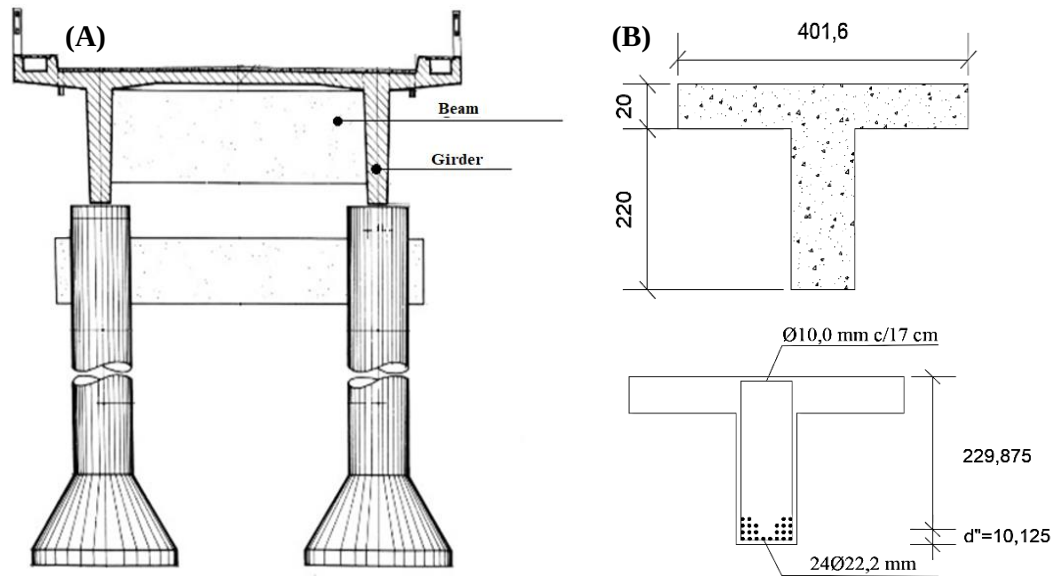
Figure 1. (A) Bridge's cross section over the Chapecó River; (B) Cross section, in centimeters, of the investigated section of the girder (Adapted from the Departamento de Estradas e Rodagem Santa Catarina, 1987).

The bridge over the Chapecó River was designed in 1987, with the objective of connecting the cities of Xaxim and São Domingos, both in the state of Santa Catarina - Brazil. The bridge studied has a total extension of 170 m (longitudinally), distributed in 3 central spans of 33,60 m, 2 spans of 28,00 m (one for each side) and 2 spans of 6,60 m, one in each extremity.

The bridge deck has a total width of 9,00 m, of which 7,20 m is for the rolling tracks, and two lanes with 0,90 m (one at each edge) are intended for pedestrians and cyclists. The deck slab is supported by two girders (30x170 cm), six beams of section 30 x 170 cm (one at each support), and ten beams of section 30 x 170 cm (two in each span - except for the end spans). The cross section of the central span of the bridge is illustrated in Figure 1A. To construct the beams and girders a concrete with a characteristic compressive strength of 20 MPa and CA-50 steel as reinforcement was used.

A preliminary structural analysis about the bridge revealed that the most critical fatigue-based condition occurs in the middle of the central spans of the bridge. Therefore, it was decided to determine the FSL of the girder present in this section (Figure 1B).

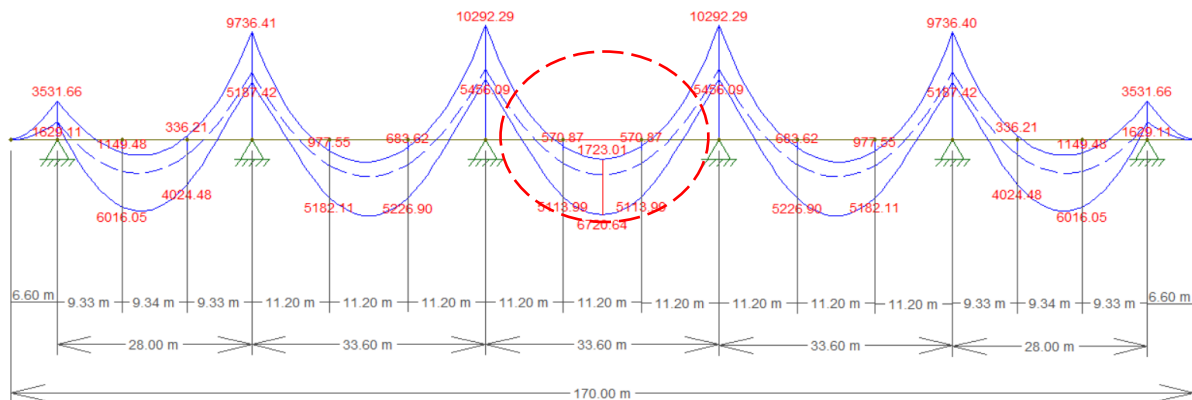
Figure 2. Envelopment of efforts due to the 300 Brazilian Load Model and  $\phi = 1.23$ .

Considering that the bridge was designed according to (ABNT NBR 7188, 1984) (current standard at the time when the project was designed), the structure was analyzed considering the permanent loads (Brazilian Load Model equal to 300 kN), and the impact coefficient ( $\phi$ ) of 1,23, specified in (ABNT NBR NB-2, 1961), as indicated by (Pfeil, 1979). The result is shown in Figure 2.

The bending moment in the middle of the central span is 6.720,64 kN.m, therefore, close to that calculated using the balance equations of forces, with a difference of 208.27 kN.m, or approximately 3.2%. In this way, it is attested that the bridge was designed according to the standards of that time (1987). The methodology to calculate the strength of the reinforcement's bars was validated by the balance of forces equations and the representative model of the bridge structure.

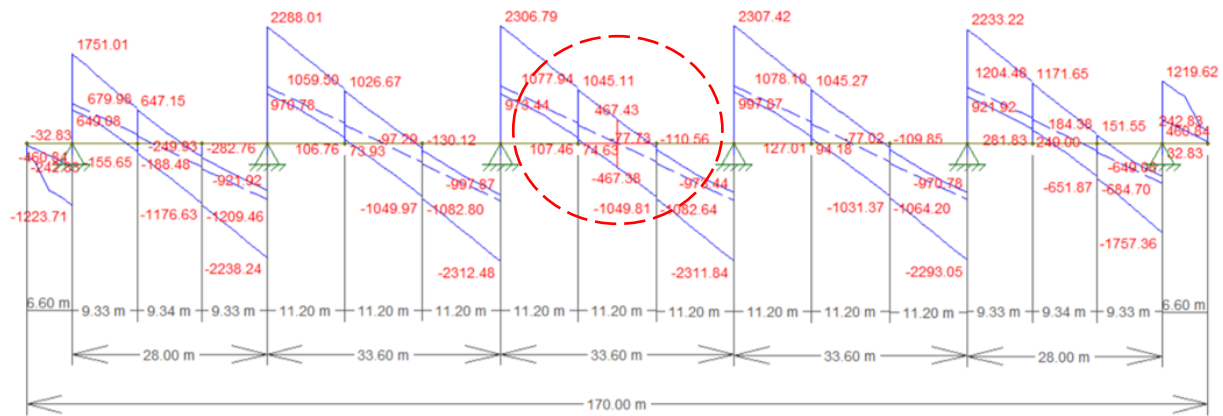
Figure 3. Shearing envelope with TB-450 increased by WCV (ABNT NBR 7188, 2013).

The fatigue efforts were determined according to the loadings of (ABNT NBR 7188, 2013). After determining the permanent loads, the Brazilian Load Model (TB-450 kN) and the crowd load were increased by the  $WCV$  ( $WCV = 1.60$ ), obtaining maximum and minimum shear forces (467,43 kN and -467,38 kN, respectively) and maximum bending moments (8.904,07 kN.m) and minimum (1.083,10 kN.m), as shown in Figures 3 and 4, in the middle of the largest span of the bridge.

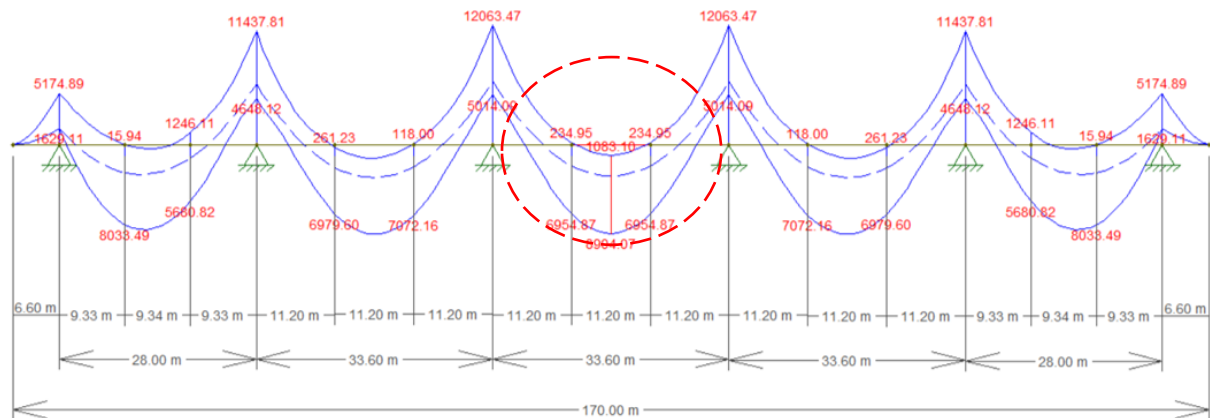
Figure 4. Bending moment envelope with TB-450 increased by WCV (ABNT NBR 7188, 2013).
